Failure Analysis and Process Improvements to a Through Wafer Via Process

Freescale Semiconductor, Compound Semiconductor Fab 1 (CS1)
2100 E. Elliot Road, MD EL609, Tempe, Arizona 85284
JanCampbell@Freescale.com

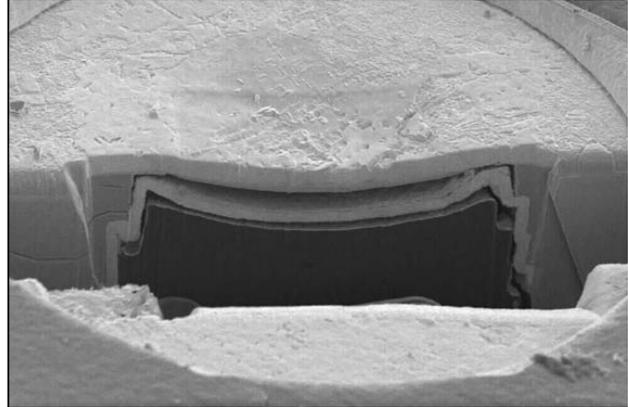
Figure 1: SEM image of metal delamination in via

To begin, the location of the delamination is determined. In this case, it occurs between the frontside and backside metal along the seed metal interface. Based on our analysis, there were several possible causes for via delamination. The root cause related to via size decrease. The aspect ratio of the via was changed when the via was shrunk. The processes, in order, that change with aspect ratio begin with the plasma GaAs etch, specifically the overetch needed to clear smaller vias. This, in turn, affects the post-etch residues, which then affect the cleans needed to remove the residues. Cleanliness in the base of the via is key to providing a surface that the metal seed can adhere to. The increase in aspect ratio also makes metal step coverage more difficult for the seed deposition, which forms the adhesion layer between the front side and back side metal. In the analysis, it was obvious that all of these process changes

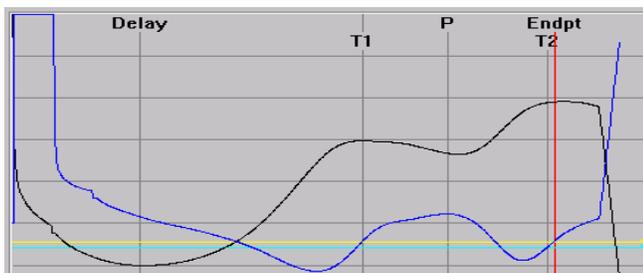
Thus, an important parameter that impacts this veil formation is the incoming thickness uniformity as discussed previously. Differences in thickness across the wafer will require longer over-etch to ensure all vias are etched to the front-side metal. The more uniform the wafer thickness, the closer in depth are each of the through-wafer vias, allowing for all vias to clear to metal at a similar time, also minimizing the veil formation. With via depth differences minimized, an optical end-point system (OES) was evaluated. An end-point system was installed and an algorithm was developed to look at the gallium emission, (Figure 2). A robust endpoint algorithm was implemented which resulted in an improved control etch and thus a consistent etch residue. Developing a consistent etch residue or veil makes the subsequent process step, veil removal, easier and repeatable.

Figure 2: Example of an end-point trace

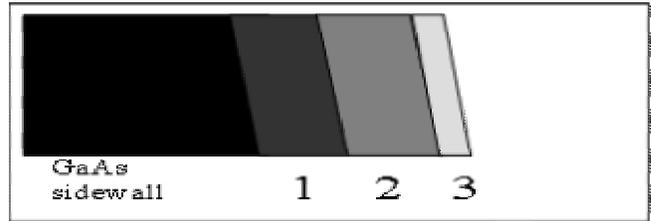
to etch through GaAs, stopping on a gold layer, the veil consists of by-products from all materials. From previous work¹, the veil material consists of a gold-rich layer, and a carbon-rich layer which is intertwined with gallium and arsenic by-products (Figure 3). Though previous work had developed a sequence of cleans steps based on this layered theory, some optimization still needed to be completed to make it more robust for via shrink.

Figure 3: Depiction of the veil layers

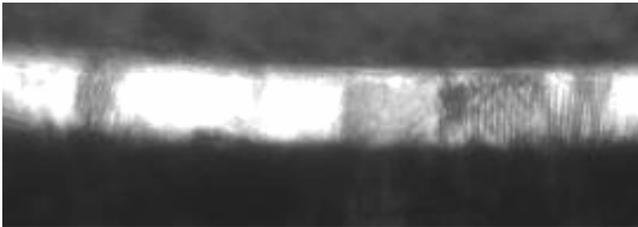
Figure 5: TEM image of adhesion layer thickness before change (160Å)

Based on internal materials experts' opinion, this layer needed to reach a critical minimum thickness to create an effective adhesion layer. This minimum thickness was on the order of 200Å. The interface layer was also thought to be a possible source of reduced adhesion and needed to be understood. When via size was reduced, aspect ratio increased, thereby making metal step-coverage more difficult. To account for the change in aspect ratio, the thickness of the metal layer was increased. The increased thickness also provided process marginality for coverage in vias to compensate for surface roughness or veil material that was not removed by the cleans (Figure 8). The metal was able to create an effective adhesion layer over surface texture or on top of veils and help prevent the via from having a source for delamination. The interface layer was investigated and related to the time delay between the clean and seed metal deposition. In keeping the existing system in place to minimize the time between processes, the interface did not prove to be an issue.

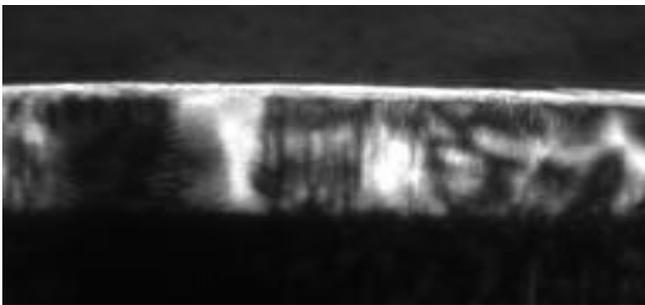
Figure 6: TEM image of adhesion layer thickness after change (320Å), note the interface layer (30Å)

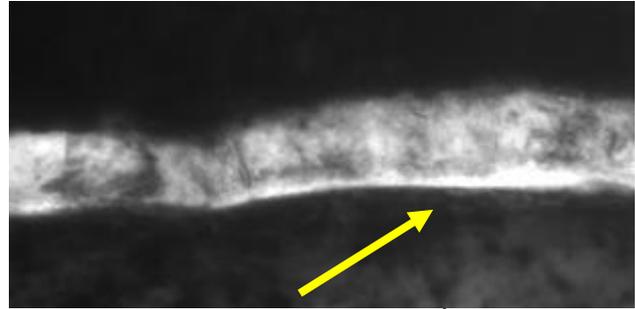
Figure 7: TEM image showing interface layer (50Å)

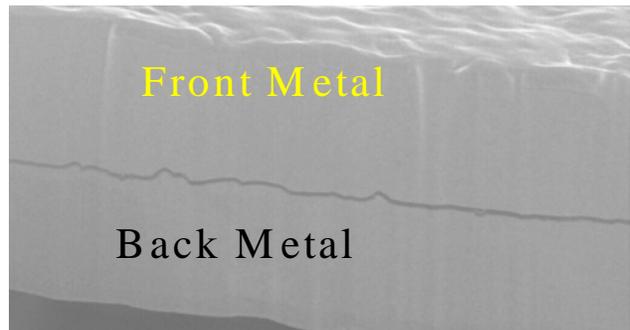
Figure 8: SEM cross section showing the surface texture of the layers

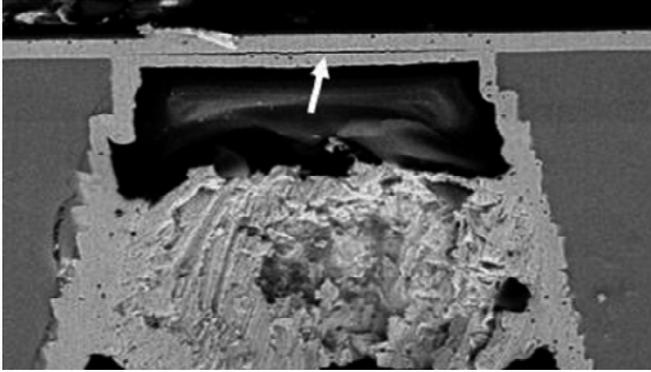
However, during the physical (polishing) preparation of samples for in-line monitoring, a weakness in adhesion was discovered. This discovery indicated a small percentage of vias still had some delamination present at their base between the front-side Au and the back-side Ti layers (Figure 9).

Figure 9: SEM view of via cross-section. Arrow indicates separation between front- and back-side metal.

Further experimentation using in-line quality SEMs (QTSEM) resulted in the discovery of an interaction between two processes which could create further adhesion issues. The processes in question were the pre-deposition wet clean and RF etch that occurs in situ, prior to seed metallization. Neither process step would have been an issue if the other would have been kept at a nominal level, but the combination at minimum levels compromised adhesion between the metal layers. Repeated experiments confirmed that either, but not both could be run at any level without these adhesion failures. The team made a small adjustment to the wet clean to provide robust adhesion to the front-side and back-side metal (Figure 10) and will continue work to optimize the module as part of a continuous improvement program (CIP).

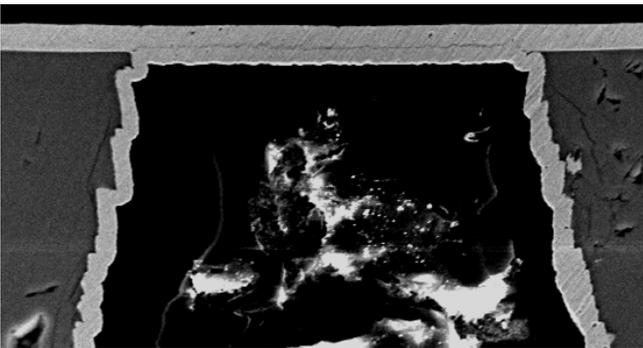
Figure 10: SEM view of via cross-section of sufficient adhesion between front- and back-side metal.
