Discovery and Elimination of Defects Causing Yield Loss on E-FET Power Amps

TriQuint Semiconductor, 2300 NE Brookwood Pkwy, Hillsboro, OR, 97124
trivers@tqs.com, 503-615-9297

Abstract

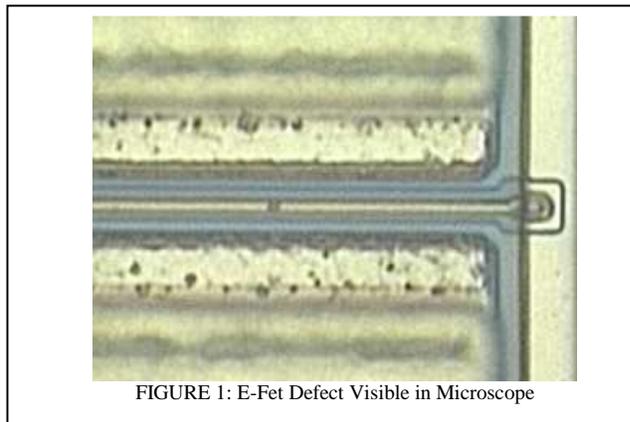
Using IV curves, our Failure Analysis group was able to track down individual leaky devices. When they examined these through an optical microscope, they were able to find defects in the gate features (Fig. 1).

FIGURE 1: E-Fet Defect Visible in Microscope

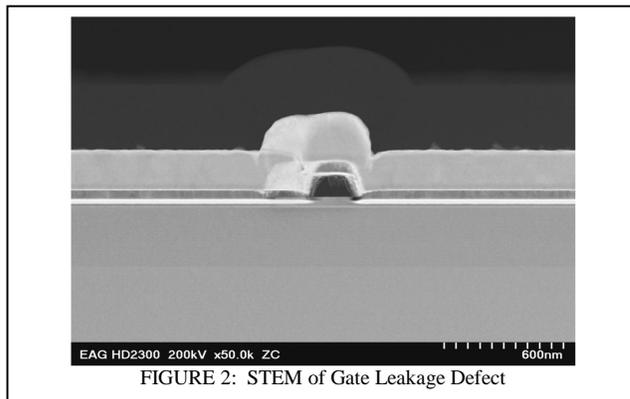
They then obtained STEM images along the width of a gate and through one of the defects (Fig. 2).

FIGURE 2: STEM of Gate Leakage Defect

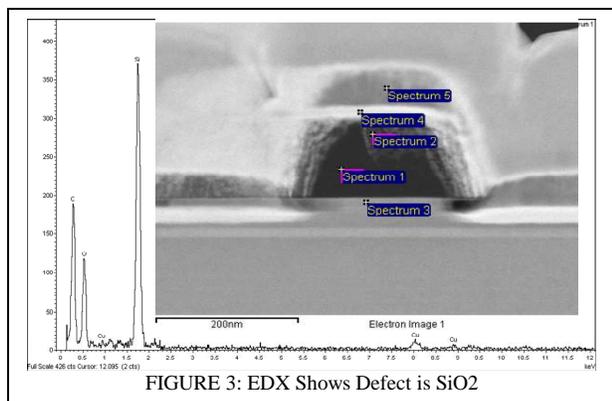
EDX was performed on the defect and the surrounding areas. The cause of the gate leakage was clearly found to be SiO_2 between the channel and the gate metal preventing the gate from shutting off in that area (Fig. 3).

As SiO₂ is the dielectric that we etch through to make gate contacts, we believe that a particle was blocking the etch. We believe this particle was then being removed by wet treatments in subsequent steps since, to date, the particle itself has never been found. It was always gone by the time analysis was done on the gate, and the only thing left behind was un-etched SiO₂.

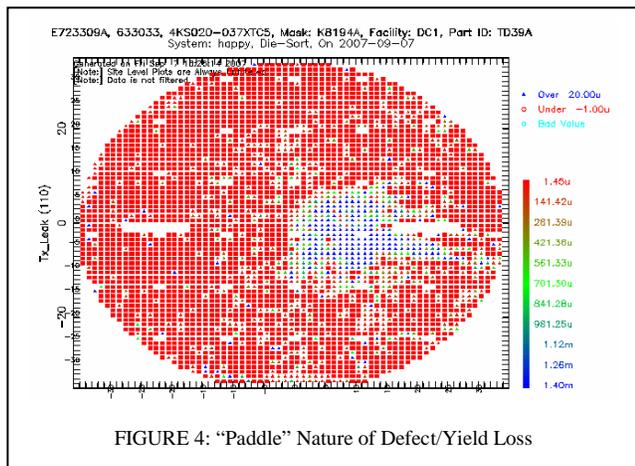
The first clue, obviously, was the remaining SiO₂. This told us to look at the steps prior to Gate Oxide etch. Another important clue was that the defects were often clustered together, near the center of the wafer, and they rotated around the center in a random pattern. Thus the failure was termed a “paddle” defect which led us to suspect that a specific tool with a paddle wafer loader was the cause (Fig. 4).

The rotation of the “paddle” signature also indicated that the wafers were not aligned in the same orientation when the defect occurred. In the end though, the most important clue was a simple first wafer effect. On all lots of this product, one wafer always yielded up to 15% better than the rest of the lot with no cluster of leaky sites, presumably, we

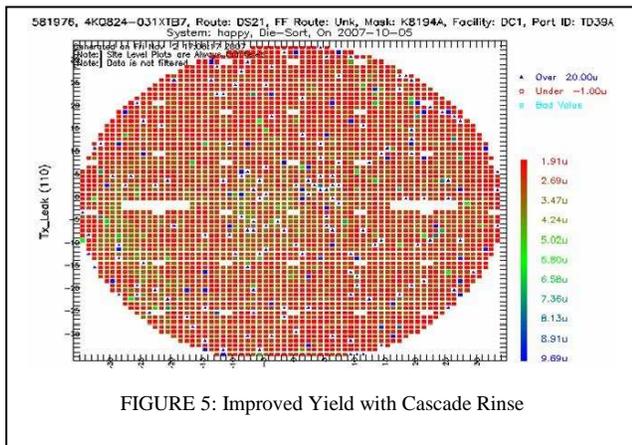
FIGURE 5: Improved Yield with Cascade Rinse

Immediate action was taken to remove this spraying action from the post-develop rinse process. The process was changed to incorporate a cascading rinse action with no exposure of the wafer to air or water spraying. This seems a simple solution to such a critical problem, but it could not have been anticipated earlier given the presumed benign nature of a water rinse. The process improvement was instituted one week ahead of the 2 month deadline. Follow up lots showed yield improving from ~83% to 93-96% for the die level leakage test (Fig. 5).
