Electrochemical Etching of Ion Implanted Channel Regions in GaAs

J. Crites, J. Dilley, S. Kittinger, W. Pickens, W. Polhamus, M. Balzan, M. Drinkwine
 Cobham Blacksburg, 3155 State St., Blacksburg, VA 24060
 Phone: 540 443-2800, E-mail: james.crites@cobhamdes.com

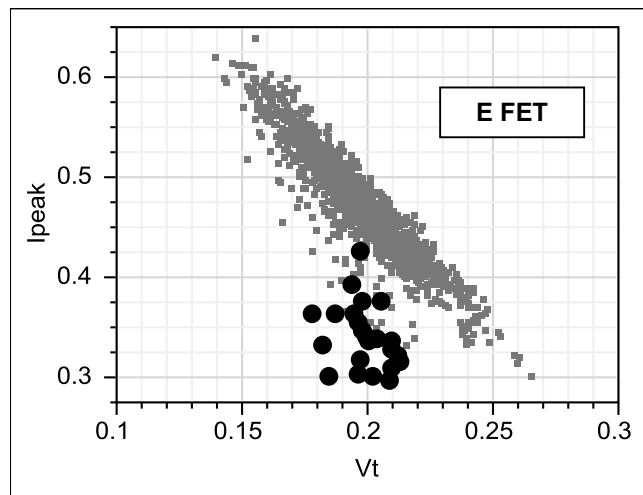
Recently we observed production MSAG wafers exhibiting abnormal dc parametric FET behavior, characterized predominantly by a drop in I_{peak} without a corresponding change in I_{dss} or V_t , as depicted in Figures 3 and 4, and resulting in yield loss at the Process Control Monitor (PCM) screening point in the process.

Figure 3. I_{peak} vs V_t shows the abnormal wafers (black data) with much lower I_{peak} than standard wafers (grey data) with the same V_t .

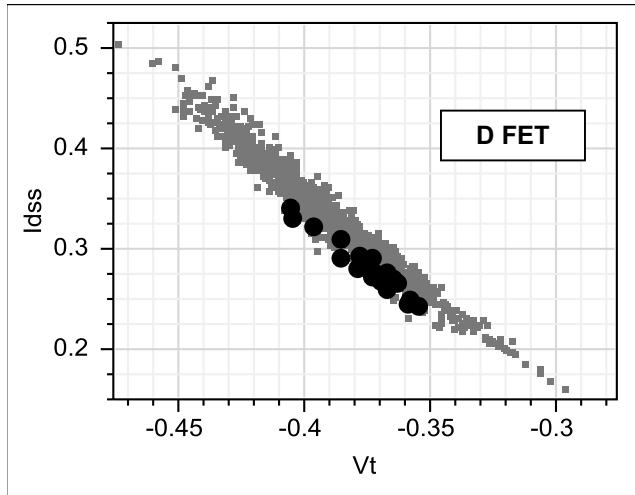
Figure 4. I_{dss} vs V_t shows the abnormal wafers (black data) have approximately the same I_{dss} as standard wafers (grey data) with the same V_t .

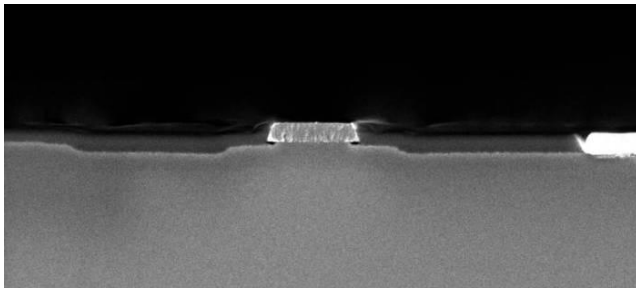
Investigation and failure analysis of the wafers with abnormal PCM characteristics traced the source of the abnormality to unintentional removal of GaAs in the channel region of the affected FETs, as shown in an SEM cross section picture of a worst-case FET (Fig 5).

Figure 5. SEM cross section picture of partially-processed MSAG FET exhibiting the corrosion problem. Note the lack of trenching near the metal contacts and the smooth etched surface. The amount of GaAs corrosion and removal varies laterally and correlates with the implant parameters used in the different regions. GaAs has not been appreciably removed under the gate electrode accounting for the unchanged value of V_t .

The root cause of the abnormality was later determined to be from extended exposure to DI water at a process step where the bare GaAs channel was exposed. Based on “common knowledge” about GaAs corrosion and etching in aqueous environments, this result may not have been totally unexpected for most practitioners in the CS IC industry. However, long-time experience with the MSAG process had never shown a marked sensitivity to GaAs corrosion at the particular operation that was identified as the root cause of the problem, nor is high sensitivity to corrosion/etching to be readily expected there, due in part to the fact that implants had not yet been “activated” at this point in the process to produce normally-conductive n-type material.

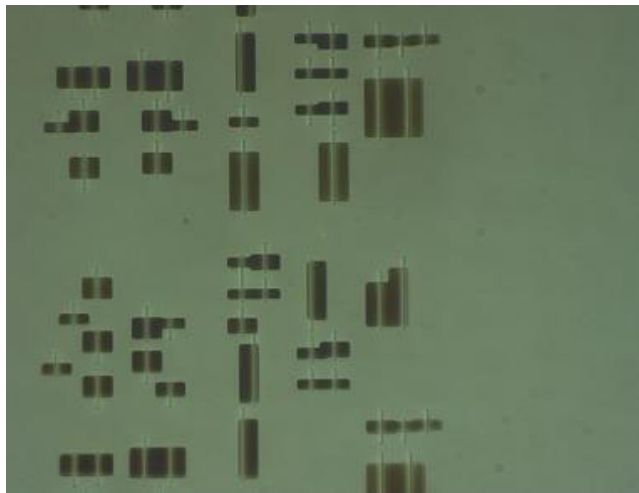
Figure 6. Optical picture of wafer after 120 minutes of DI water exposure. Only implanted regions with gate-metal contacts show discoloration, but material has not yet been removed. Evidence of etching shows up later after exposure to HCl.

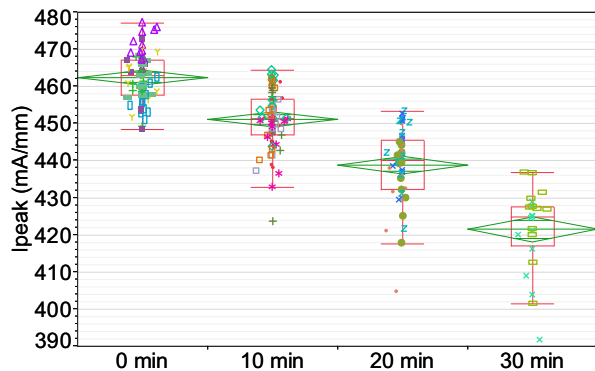
After identifying DI water exposure time as a contributing factor for device variability (and PCM yield loss in extreme cases), we proceeded with evaluation of key device parameters as a function of DI water soak time at the step in the process identified as the most sensitive to GaAs corrosion. Figures 7 and 8 show the results of split-lot experiments in which DI-water soak time was investigated over times ranging from “zero” to 40 minutes. Not surprisingly, the very long DI water soak time of 30 minutes showed excessive degradation of FET current as characterized by the I_{peak} parameter. The low I_{peak} values for 30 min soak time were similar to I_{peak} values for the problem lots that initiated this investigation. Conversely, we observed that leakage (I_{leak} in Fig 8), was reduced (improved) for longer DI water exposure time, showing a stronger effect than that normally observed for I_{dss} vs I_{leak} correlation. Furthermore, in our initial efforts to control the process better, the DI water soak time was

Figure 7. Results of split-lot experiment showing monotonic reduction in FET I_{peak} for increasing soak time in DI water.

set to “zero” via strict enforcement of the manual loading/unloading process by the operators, with a consequence that wafer failures were subsequently observed for high FET reverse-bias leakage and higher-than-normal FET current. We therefore concluded that a small amount of GaAs removal in the surface region of the FET was more beneficial for leakage reduction than it was detrimental for current reduction. As an interim approach, a small amount of DI-water-soak-time has been specified as standard, resulting in improved FET parameter control and increased yield at the PCM screening point. Further process improvement is planned to provide better control of the small amount of GaAs etching required for optimum process control of PCM target values and improved yield.

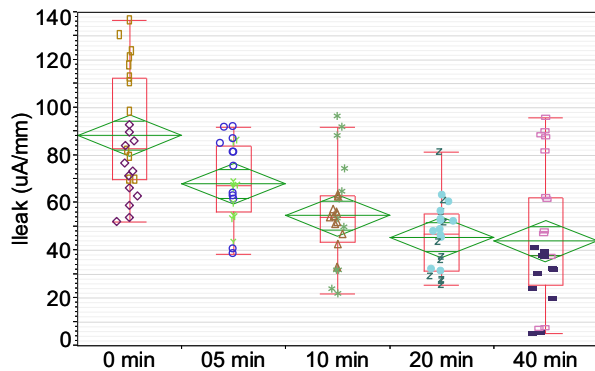
Figure 8. Results of split-lot experiment showing monotonic reduction in FET reverse-bias leakage for increasing soak time in DI water.
