The Use of a Structured Approach to Solve Yield Limiting Defects in a Compound Semiconductor Factory

Jan Campbell, Qizhi He, Howie Yang, Martin Ivie,
John Gibbon, Darrel Lupo, Dario Nappa, Jerry Beene

TriQuint Semiconductor Product Sector
Compound Semiconductor Texas
500 W. Renner Rd Richardson, Texas 75080
Phone: 972-415-3218 Fax: 972-994-5768 Email: jan.campbell@tqs.com

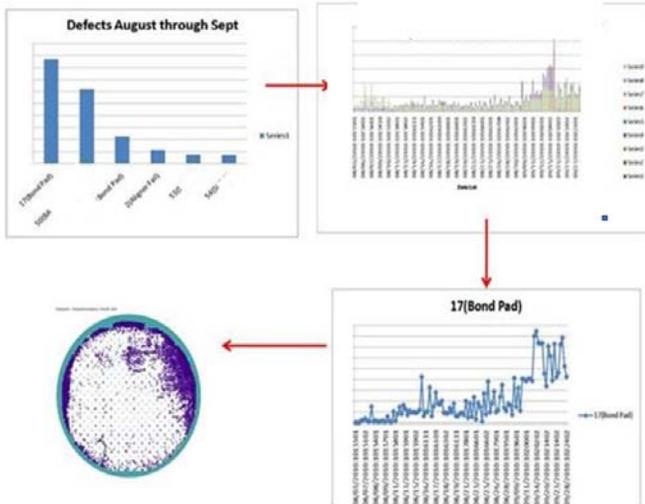
Fig. 1: Yield Loss Trends at the start of the project

TriQuint Texas inspects 100% of its wafers at Final Outgoing Inspections (FOI). At FOI there was a significant yield loss due to in-line defects caused by processing issues at previous steps (see Fig. 1). Isolating the defects and implementing in line inspections to discover where these occurred had to be part of a detailed plan carefully implemented since adding any such step is non-value added.

In Fig. 1, the upper left graph (defects August through Sept) indicated that the pad residue defect was approx. equal to its historical average. If only this Pareto chart was studied, it might not have been noticed that the defect was trending up and the reaction might have been to do nothing at all. However, as can be seen from lower right graph in Fig. 1, there was a turn on, which indicated that something had changed in the process, and the cause of this "turn on" had not gone away. This indicated that the problem was related to a special cause.

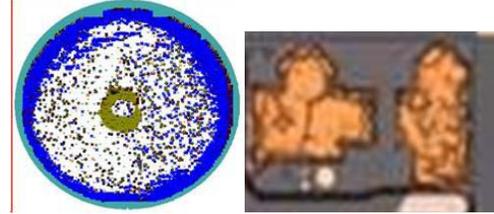
Fig. 3: Severity and Location of Defects

The defect was first discovered at AOI inspection, however at this point the resin cavities are present and rework is not possible. The defect was seen only on the Au

bond pads. It occurred on the outer edge of the wafer. The severity and the location of the defect can be seen in Fig. 3:

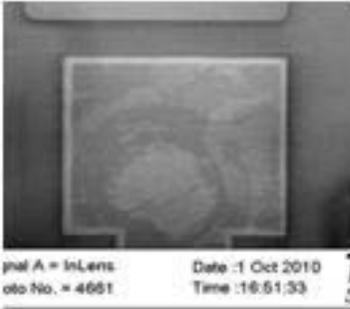
Fig. 5: Pad Residue Defect

by the un-patterned etch prior to resin encapsulation patterning. To verify this, wafers from Device B were pulled after the post etch process ash step and examined using a SEM. In Fig. 5, a defect is already visible using the SEM; however it was not seen under normal microscopy at this stage.

The where was clearly identified at this point in the process, occurring after Ash in the patterned etch route.

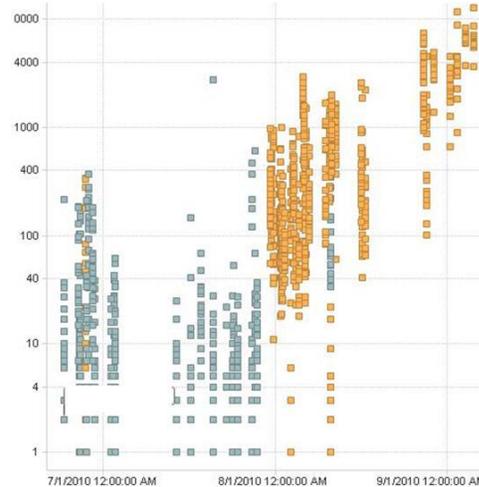
Fig. 6 Turn on Dates

The defect has appeared randomly at FOI, but at such a low level that it was not given priority. There was a clear turn on in August of 2010, in which the defect stayed at higher levels of yield loss. We examined the line for

hardware changes that occurred during this time period. Trend charts were also examined that might indicate unintentional process shifts in related tools. In Fig. 6 the turn on date is displayed.

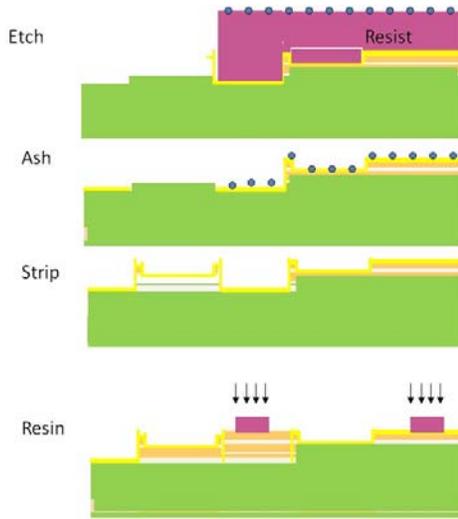
Fig. 7: Residue Formation Mechanism.

It was hypothesized that the material sputtered from the etch tool during the patterned etch reacts with the negative resist in the ash leaving a residue which adheres to the bond pads. This complex residue reacts with the unexposed resin on the bond pads and leaves residue after develop clearly seen in the Rudolph (see Fig. 7)

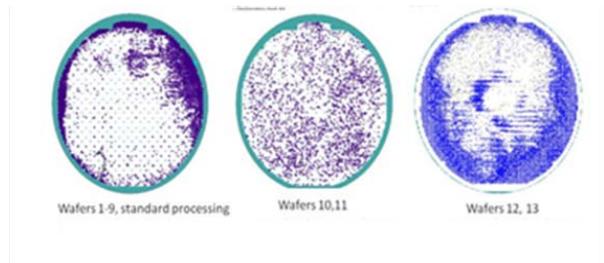
Fig. 8: Defect Maps of Splits

The wafers were processed through resin patterning and inspected using a Rudolph In-Line Inspection Station. The control group (test 1) exhibited the defect with a yield loss of that had been seen in recent weeks. In test two, the strip and ash were reversed and the defect did not occur, but there were residue defects from the wet strip bath. In test three, the only difference was to increase the ash time, with additional exposure to O2 plasma increased visual defects as can be seen in on the right map in Fig. 8

This testing was reproduced several times, but with the scrubber step removed and a two-step wet strip implemented. The result of this implementation eliminated the defect rate from this process step
