# Reducing Broken Thinned GaAs Wafers During Backside Processing

Fadi J. Bahouth

RF Micro Devices, 7628 Thorndike Road, Greensboro, NC 27409  
Phone: (336) 678-8005, e-mail: [fbahouth@rfmd.com](mailto:fbahouth@rfmd.com)

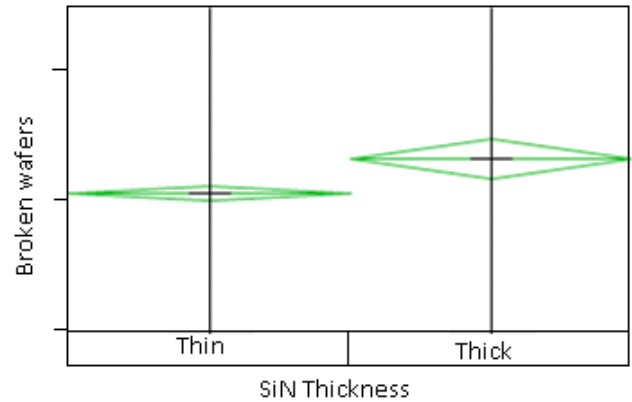
**Figure 4**, Effect of final SiN glassivation thickness on wafer breakage

Final glassivation thickness was determined to be an important factor in wafer breakage; products that had thicker silicon nitride tended to have higher breakage rate (figure 4). This is due to the increased film stress which is reflected in wafer bow. Changing the glassivation thickness is a difficult process that may require customer approval, so we set out to attempt to reduce wafer bow. Here we focused on the stress

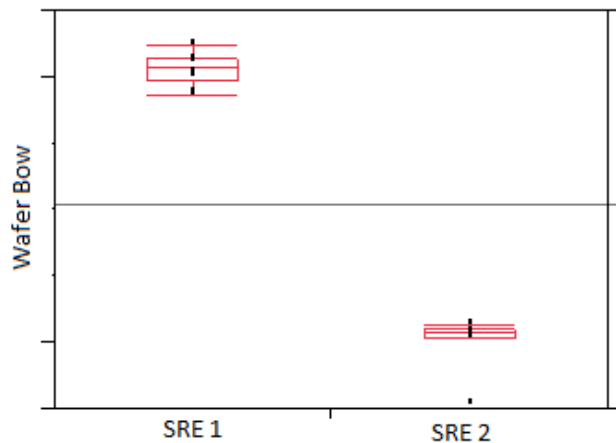
**Figure 5**, Effect of SRE solution on wafer bow

relief etch chemistry and whether an alternate chemistry would have an impact on wafer bow, and thus reduce breakage. It did (figure 5). Changing the SRE chemistry led to a 25% reduction in wafer bow, which translated to a reduction in broken wafers at demount. It also reduced the number of wafers broken after demount as higher stressed wafer tended to break more frequently during transportation or saw frame mounting.

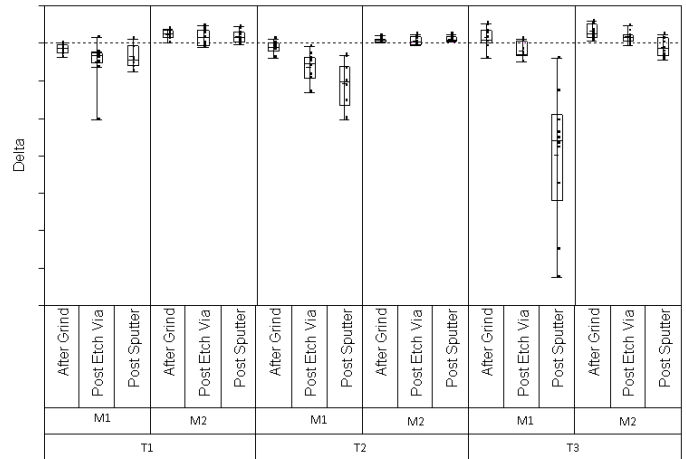
**Figure 6,** Effect of bonding material composition and thickness on wafer flatness at various steps.

Careful inspection and observation proved that there is no substitute for time spent in the fab looking at product. This is where we observed that some wafers were “wavy” around the perimeter prior to the plating operation. Subsequent height measurements showed that some wafers were significantly higher at the edge than they were at the center. They were flat when bonded, but that was no longer the case just prior to plating. The bonding medium was wrinkled around the perimeter of the wafer and caused the wafer to lift slightly from the sapphire. We hypothesized that the elevated temperature at seed layer sputter deposition was the direct cause. These wafers were prime candidates to break, as any pressure from the plating contact is enough for a break to initiate, and that is precisely where the wafer will come apart at demount.

We worked with our bonding medium supplier toward a solution that required a fairly simple modification of its composition. We hypothesized that such a modification would make it more resistant to our process and environmental conditions in the fab. Our supplier provided us with a sample for evaluation. Figure 6 shows the impact of this new material on maintaining a uniform stack height (this is the total sum of the sapphire, wafer, and bonding medium thickness) as a function of process temperature and applied thickness. It is clear that this modified material is significantly more uniform at higher temperatures and more robust relative to its applied thickness.

The bonding medium supplier agreed to commercialize this modified product, and supply it to RFMD to replace the one we were currently using. We have seen a significant drop in broken wafers after we implemented this change.

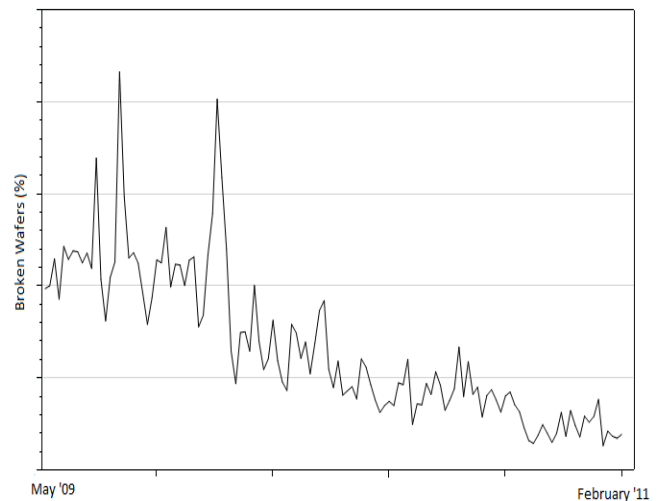
**Figure 7,** Broken wafer trend over an 18 month period since this project began

For the past 18 months we have diligently worked toward identifying every existing source of wafer breakage, and sought a solution. These ranged from equipment handling issues, to intensive and continuous operator training. The results have been encouraging as can be seen in figure 7. This figure also shows that we remain prone to periodic fluctuations in broken wafers, and understanding its causes will be important in realizing additional gains.
