# Successful GaAs Backend Process Improvement

Tom Hand, Scott Famosa, Jennifer Welborn, Daniel Nercessian

Skyworks Solutions, 20 Sylvan Road, Woburn, MA 01801 [Thomas.Hand@Skyworksinc.com](mailto:Thomas.Hand@Skyworksinc.com) (781) 376-3539

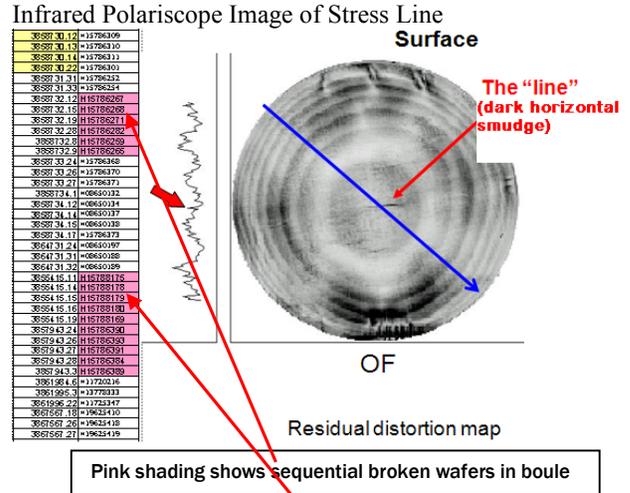
**Figure 1: Infrared Residual Distortion Map**

The team looked at process commonality. There was a commonality of higher breakage on some substrate lots. Further analysis of the suspected boules with an infrared grey-field polariscope showed an anomaly “the line”. (See Figure 1) The breakage was always a horizontal crack in the same location as the line. This was an interesting finding, but the team realized that implementing a screening process would not be a manufacturable solution, and moved on to the realization that we had to develop a process that would overcome substrate stresses.

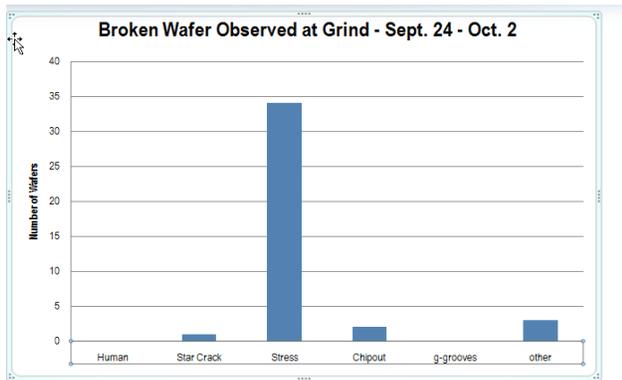
Figure 2: Breakage Summary

•Data Collect added to all Grind recipes to track types of breaks  
 •Data collect released & active from September 24

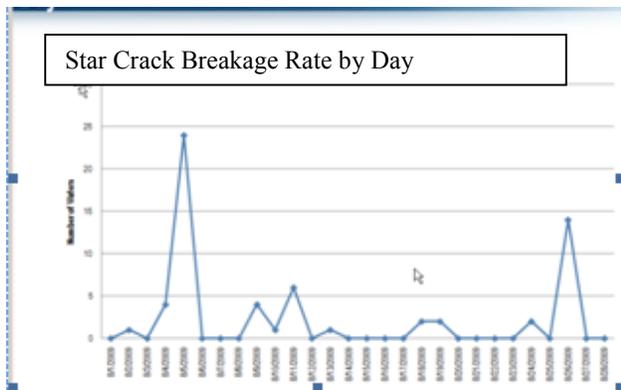
Figure 3: Star Crack Daily Breakage Rate

Figure 4 below shows a “star crack” and the chart above shows breakage rate, with spikes of up to 25 wafers/day. Star cracks were traced to a particle contamination on a robot transfer arm. When a particle attached to the arm, it would cause a crack on subsequent wafers in the run. Initially we focused on detection and containment. This included frequent transfer arm PM, and equipment changes to use only DI water for the arm cleaning. We also modified the cleaning nozzle pattern to provide a higher pressure, focused spray to the arm pickup area. We then worked with the vendor on prevention, and installed an automated transfer arm cleaning station that cleans between each wafer. Star cracks are no longer an issue. We now see less than one star crack per week.

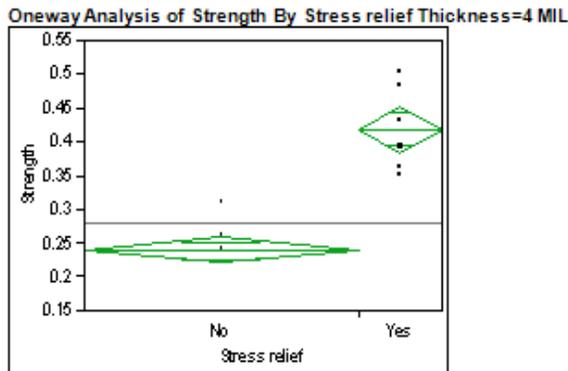
Figure 5: Wafer Strength ANOVA

During this process of improvement, we validated all grind process changes with wafer strength measurements, and grind breakage trend analysis. We have a tool available which will measure the breaking strength by applying a force to the wafer until it breaks, and recording the force. Figure 5 below shows data we used to implement a stress relief etch. We also used this method to make decisions on grind factors such as wheel type (solid vs. slotted), feed rate, table rotation, spark out, tape type, and wheel vendor.

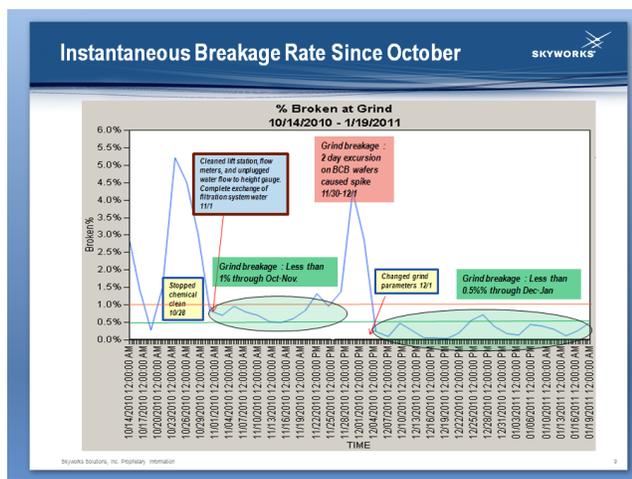
Figure 6: Effects of Process Changes on Breakage

Figure 6 below shows a timeline of yield vs. process changes that were introduced to the grind process. Using the data analysis system defined above, we are able to gauge the effect of process changes and react quickly to excursions that may occur. Fortunately, the grind breakage rate has been consistently low for a long time. We are currently running at about 0.2 percent breakage rate at grind for GaAs wafers 4mils – 8mils thick.

- Investigate table angle effect on grind breakage. Table angle is a critical parameter that affects the down force of the grind wheel, and can also cause variable stress patterns across the wafer that affect breakage rate. Having the correct table angle is a necessary starting point.

- Investigate impact of recirculating/filtered grind water chemistry on grind process. We use a filtered, recirculating loop to supply water to the grinders. We found that breakage events closely followed filtration system maintenance events. The process of record was to periodically replace 300 gallons per week with DI water. When that much water was added, we noticed a correlation with degraded grind performance. We also had a PM process that used a GaAs etchant to open up the clogged pores on the grind chucks. The effect of both the etchant and large adds of DI water is to allow the ground GaAs to go into solution, rather than suspension, making it difficult or impossible to filter. We believe the water chemistry change altered the surface tension, affecting the wetting of the cutting water. We switched our process to adding the DI water gradually, ½ liter at a time, every grind run, and eliminating the chemical etching. When we got rid of the large water adds, and the etchant PM, our grind process and filtration costs improved dramatically. The grind breakage rate stabilized at 0.5-1.0 percent.

- Investigate grind parameters with DOE, analyzing break strength data and the grind wafer breakage results. We made a permanent change to our grind parameters, slowing the removal rate for both coarse and fine grind, and reduced the amount removed by coarse grind and increased the amount removed by fine grind. This change allowed us to be consistently below 0.5percent.

- After this, we continued to improve the grind breakage rate by qualifying a new “low stress” grinding tape. This tape is marketed as having no dimensional changes during the UV exposure, and our observations supported this claim. There was visibly lower post-grind and expose warp and bow using this tape. This change allowed us to be consistently below 0.2 percent grind breakage.

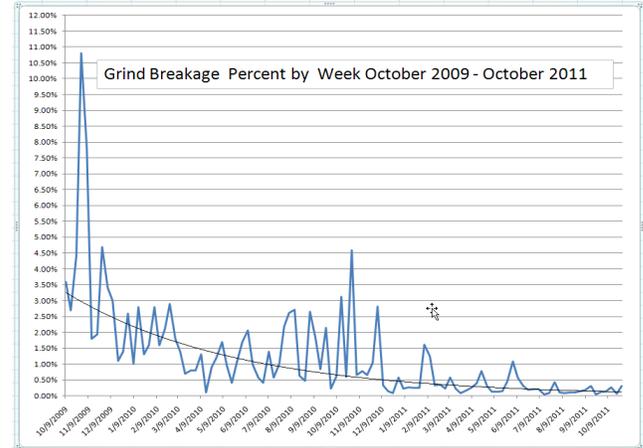
Figure 7: Skyworks Two Year Breakage Trend

As a result of our never-ending quest for perfect quality, Skyworks has been able to effect a 90 percent reduction in GaAs wafer breakage and to increase the line yield by 3 percent over the last two years. Figure 7 below tells a compelling story of the success of the team's efforts.
