Defects ('Seams') Caused By Clear Field Mask Chrome Dimensions

Richard Nutter

HRL Laboratories, LLC, 3011 Malibu Canyon Road, Malibu, California 90265

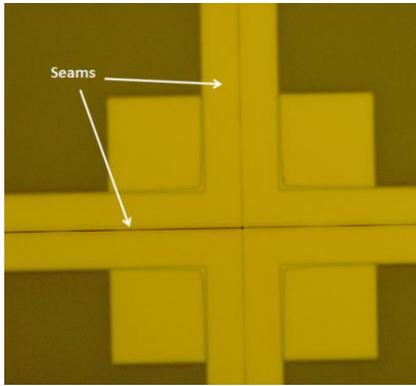
Seams are defined as the small lines that are optically detected at the edges of the exposure field (Fig. 1). Seams, for the most part, are benign. For the image reversal process, a trench (Fig. 2) is formed in this region along the field borders. However, in the corners there are openings that reach the substrate. These areas could potentially result in small metal poles or spikes remaining on the surface depending of the type and method of deposition. These posts probably do not survive the lift off process, however they could 'pop' off and redeposit onto the wafer or impact future layer processing if they remain. In the positive tone mode, a small thin resist line remains along the field edges (Fig. 3). The effects of a seam in this mode could be worse. During etch steps, where positive resist is more widely used, a small unetched material barrier would remain. Again, this would be located in the streets but easily visible during optical inspection flagging the lot for additional defect review, slowing its progress.

Fig.1 Optical image of a resist seam using Image Reversal Process

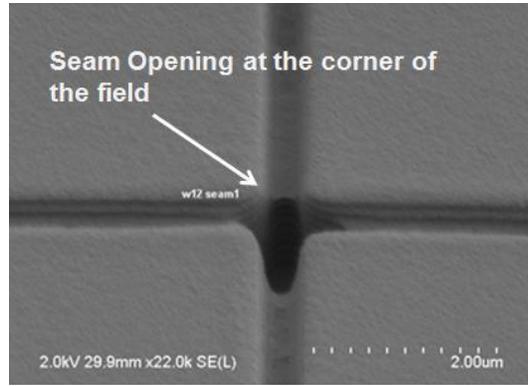
Fig.2 SEM image of an Image Reversal resist seam

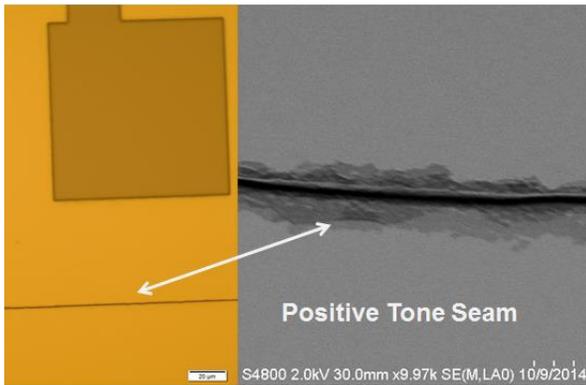
Fig.3 Optical and SEM image of a Positive Tone resist seam

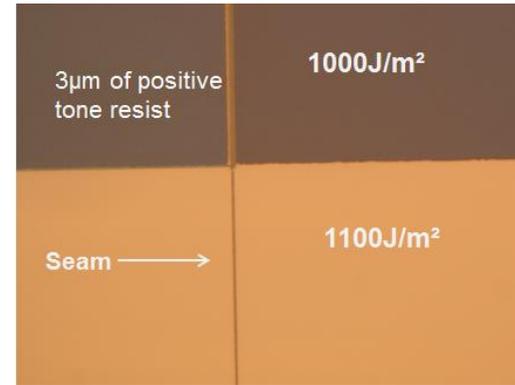
We were able to replicate the seams on processed wafers with a dose matrix and those reticles. A significant under dose of the resist (Fig. 4) showed distinct seams. This gave us a test bed to develop and test solutions to understand and resolve the issue. During a brainstorming activity, several items were identified as possible causes: stepper blade location, stepping distance, magnification, exposure, and chrome boarder field size. Experimentation was done to either validate or exonerate these potential root causes. A result from one experiment showed that if the exposure was increased, the seam was minimized significantly.

Fig.4 Optical image of a replicated seam in Positive Tone resist.

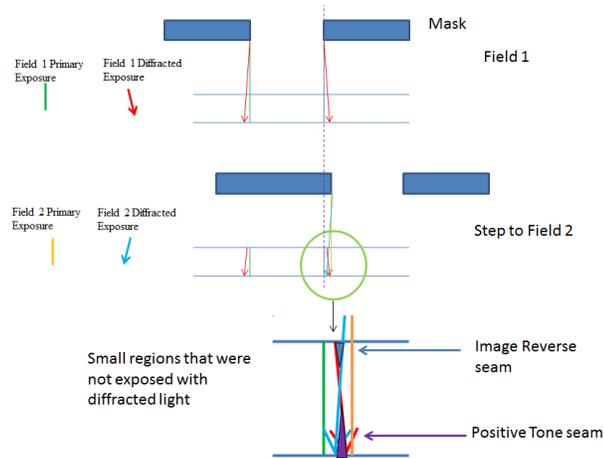
After all solutions were tested, the root cause was determined to be that the chrome border size on the mask was too small. If the chrome boarder is smaller than the expected field size and stepping distance, there will be no field to field overlap resulting in unexposed regions between steps. There will be some light diffraction that will expose some regions of the resist but the intensity will not be enough to cause a significant reaction (Fig. 5 and Fig. 6).

Fig. 5 Diffraction of light between 2 adjacent exposure fields

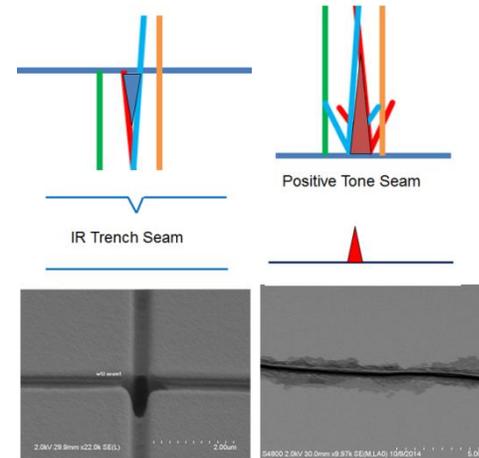
Fig. 6 Results of diffracted light on IR and Positive Tone Seam generation

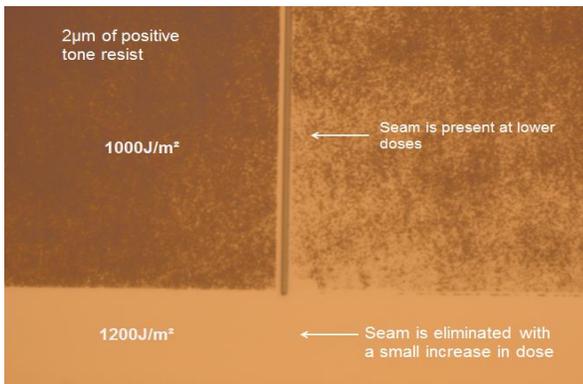
Fig.7 Optical image of exposure impacts on the seam

For current masks in house, increasing the dose by $200\text{J}/\text{m}^2$ + (depending on resist thickness and substrate material) eliminated the seam for both processing modes (Fig. 7). However, some additional optimization will be needed for layers with sensitive critical dimension. With the help of our mask vendor, clear field border measurements were gathered and several experiments were repeated to show that the chrome boarder on the mask must be at least $0.5\mu\text{m}$ larger than the desired field size to eliminate the seam. This translates into a $0.1\mu\text{m}$ larger field size at the wafer using a 5x reduction stepper. Finally, all new clear field masks will need to be ordered with a larger boarder to prevent this issue.
