Seam Defects Caused By Clear Field Mask Chrome Dimensions

HRL Laboratories, LLC

Keywords: Photolithography, seams, mask, stepping distance, Positive Tone, Image Reversal

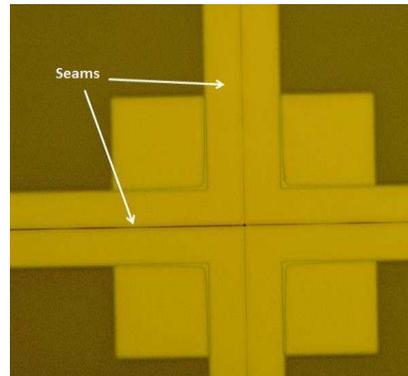
Fig.1 Optical image of an Image Reversal seam

Seams are small lines located at the edges of the exposure fields (Fig. 1). For the image reversal process, a shallow trench is formed in this region along the field borders. However, in the field corners, the trench depth reaches the substrate (Fig. 2). During metal deposition and lift-off, small metal poles or spikes could remain on the surface in these areas. These defects probably do not survive the lift-off process, however they could pop off and redeposit onto the wafer or impact future layer processing if they remain.

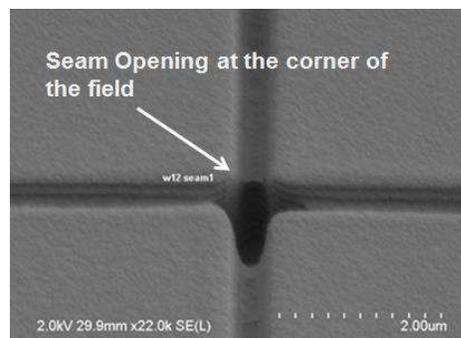
Fig.2 SEM image of an Image Reversal resist seam

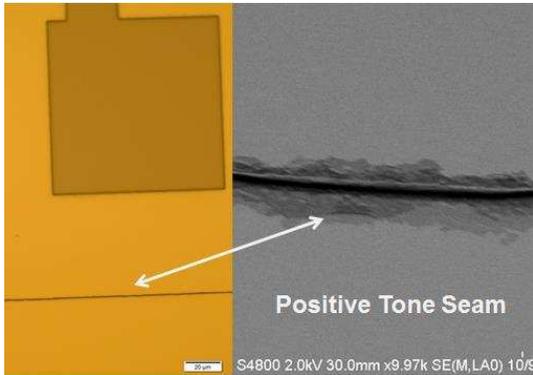
In the positive tone mode, a small thin resist line remains along the field edges (Fig. 3). The effects of a seam in this mode could be worse. During etch steps, where positive resist is more widely used, a small unetched material barrier would remain. Again, this would be located in the streets but easily visible during optical inspection, flagging the lot/wafer for additional defect review and slowing its progress.

Fig.3 Optical and SEM image of a Positive Tone resist seam

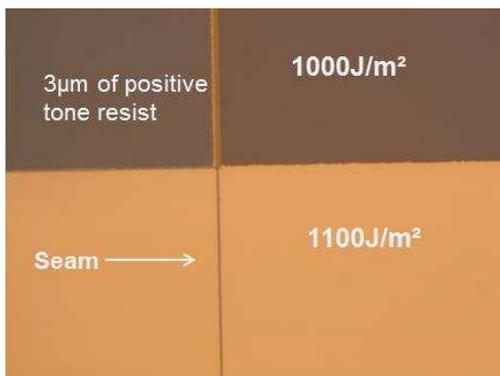
Before testing could begin, the defect needed to be replicated. This was done by processing wafers with a dose matrix and the reticles from known problematic (seam generating) layers. A significant under-dose of the resist showed distinct seams (Fig. 4). This gave a test bed to develop and test solutions to further understand and resolve the issue.

Fig.4 Optical image of a replicated seam in 3µm Positive Tone resist.

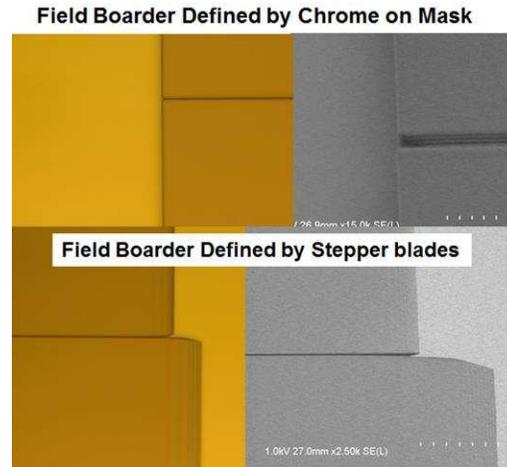
The blades are positioned a measureable distance from the edge of the chrome border so that the on-wafer field edge is defined by the mask chrome edge (clear field only). Screening experiments have shown that when a blade encroaches into the clear-field region of the mask, the diffracted light from the exposure results in a poorly defined edge in the resist (Fig. 5). So for this reason, the blade location is not causing the issue.

Fig.5 Optical and SEM images of Mask Chrome and stepper blade defined field border

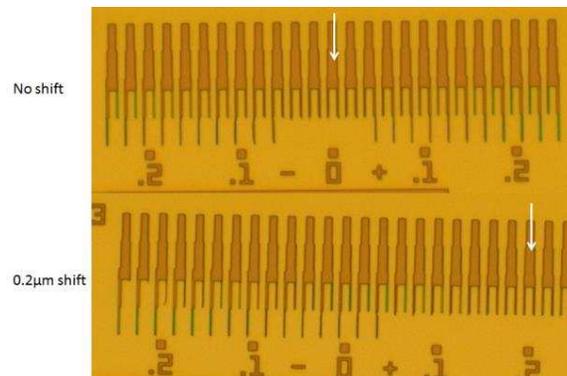
Steppers are very precise in their stepping distance accuracy. To validate this, a Canon stepping distance monitor was processed with no offset then again with a 0.2µm offset. As Fig.6 shows, the control wafer sits at 0 on the vernier alignment targets, whereas the wafer with a forced stepping distance of 0.2µm shows the same error shift on the overlay verniers. The stepper is performing as it should. Then a wafer was processed with a shorter stepping distance using a known seam generating causing field to field overlap. Under these conditions, the seam was eliminated. This was the first indication that the mask field size may be part of the problem.

Fig.6 Optical image of overlay verniers with and without a stepping shift

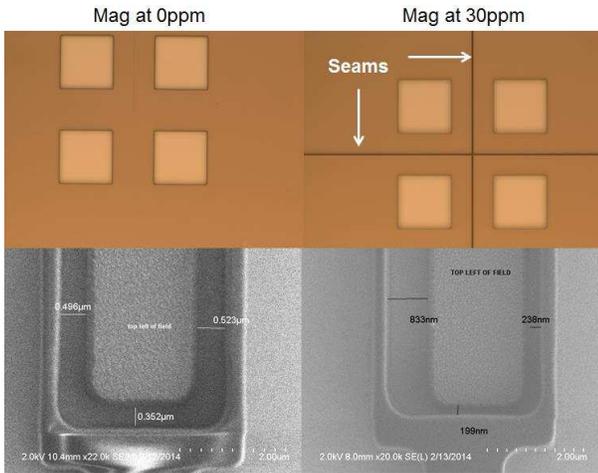
Based on the stepping distance results, the field size could also be modified by pushing the magnification parameter in the stepper to its limits, ~30ppm. This effectively made the field smaller and the result was seam formation at the field edges. However, since the entire field was shrunk, the alignment within the device shifted to an unacceptable level (Fig. 7). Increasing the magnification would have eliminated the seam, but a similar but directionally opposite alignment issue will occur across the field becoming worse at the field edges.

Fig. 7 Mag effects on Seam generation and feature alignment results

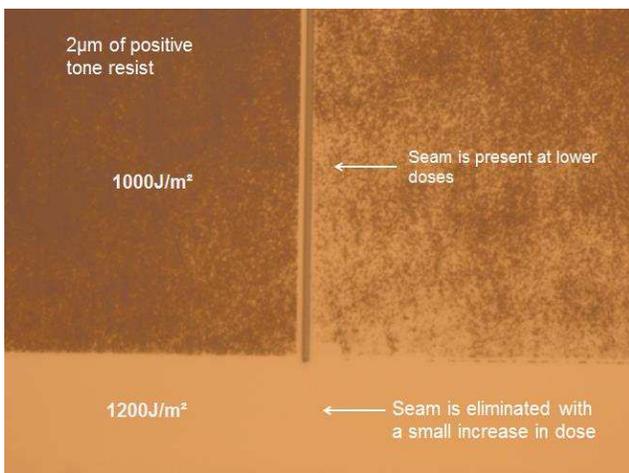
One parameter that did eliminate/minimize the seam was dose. By increasing the dose by ~200J/m² (depending on resist thickness), the seams for both positive and image reversal processes were minimized and in most cases eliminated (Fig.8).

Fig.8 Optical image of exposure impacts on the seam

For current masks in house, increasing the dose (the main contributing factor to seam formation) by 200J/m² + (depending on resist thickness and substrate material) will eliminate the seam for both processing modes (IR and Positive Tone). However, some additional optimization will be needed for layers with sensitive critical dimension.

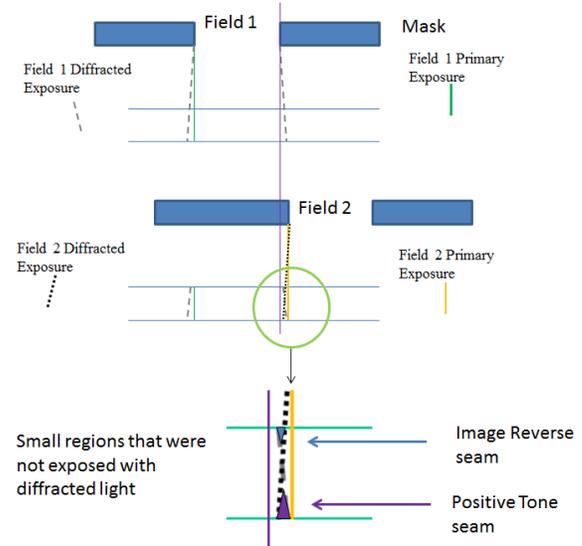
field size and the stepping distance matches the field dimensions, there will be no field-to-field overlap resulting in unexposed areas between steps. There will be light diffraction that will expose some regions of the resist but the intensity will not be enough to cause a significant reaction (Fig.9 and Fig.10).

Fig. 9 Diffraction of light between 2 adjacent exposure fields

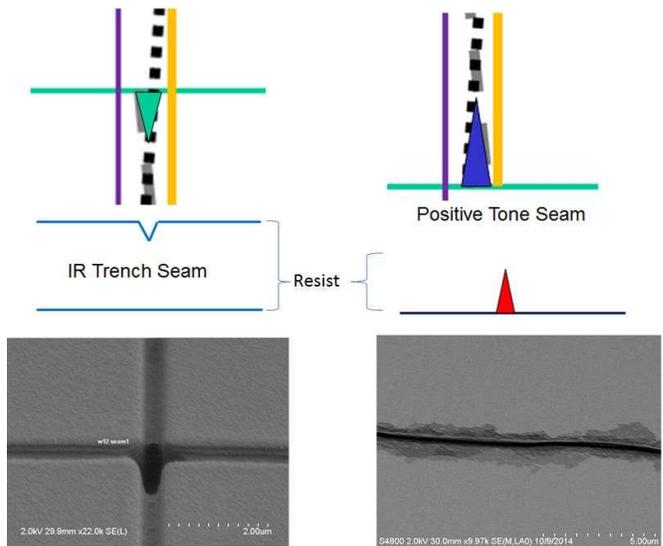
Fig. 10 Results of diffracted light on IR and Positive Tone Seam generation

From the results of these experiments, the **root cause** of the seam formation has been verified as the result of the size of the bright-field chrome border being smaller than the field to field stepping distance.

Finally, to address the root cause, all new masks will be ordered with a slightly larger chrome border size (at least 0.5 μ m) for clear-field layers to ensure field to field overlap occurs, preventing seam formation on all processes including those that require lower doses.

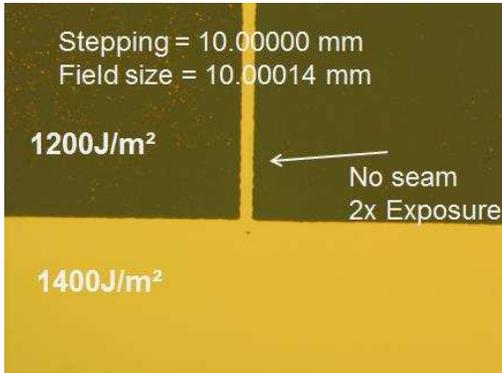
With the field size dimensions known (10.00014mm), a dose matrix was run, keeping the stepping distance constant at 10mm. The region between the stepping fields received 2x the exposure dose (field-to-field overlap), clearing the resist along the field borders (Fig. 12).

Fig. 12 Effect of field size, stepping distance and exposure on Seams in 3 μ m PR

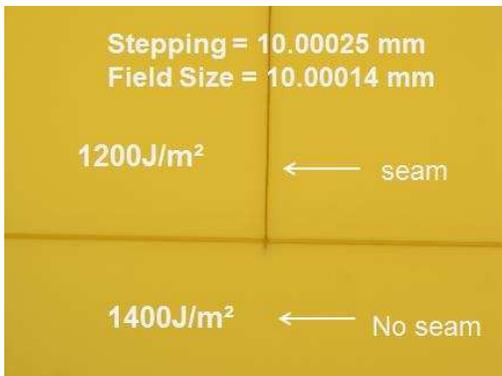
The stepping distance was then increased from 10mm to 10.00025mm (0.11 μ m larger than the chrome boarder dimensions) to simulate a smaller field size with respect to the chrome boarder opening. A dose matrix was run and the results confirmed the theory. The seam was present in the under-dosed fields and eliminated in the higher-dose fields (Fig. 13).

Fig. 13 Effect of field size, stepping distance and exposure on Seams in 2 μ m PR
