ELECTROCHEMICAL ETCHING IMPACT ON GaAs PROCESS, MASK DESIGN AND DEVICE PERFORMANCE

I. Hallakoun¹, T. Boterashvili¹, G. Bunin¹ and Y. Shapira²

Abstract

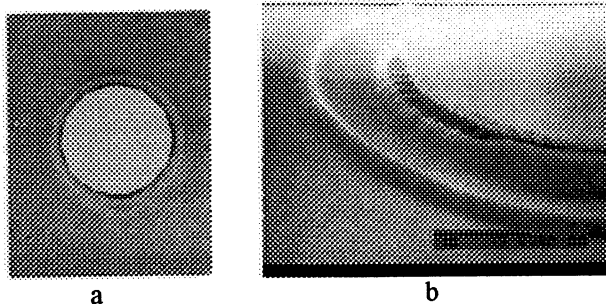
The first undesired etching effect described below examined the use of phosphoric acid based etchant⁵ with SiN mask for mesa etching. Fig 1a shows a metal pattern on the top of a deep mesa. This is a typical picture for in-line visual inspection by metallurgical microscope. No significant undercut of lateral etching may be observed from the top view. However, a detailed side view inspection by SEM shows pronounced undercut, due to the enhancement of the etch rate in the vicinity of the exposed edges of the metal (Fig1b).

Fig 1.a.-Top view of the metal pattern with SiN mask on top of deep mesa. b-SEM Side view of the pattern shown in Fig 1a. (Metal with two steps mesa etching)

It can be seen that once the metal surface is exposed the etch rate is locally enhanced (by an order of magnitude), resulting in undercuts underneath the metal layer. This undercut may not be properly detected from top view. This phenomena is avoided by changing the bias in the mesa etching mask (Fig 2.) i.e. photoresist should cover the metal with margin of at least the expected etch depth (assuming lateral etch rate equals perpendicular etch rate with no metal present in the solution).

Another approach to the problem is to change the whole process flow (if possible) so that all deep mesa etching steps are performed before any metallization is applied to the wafer.

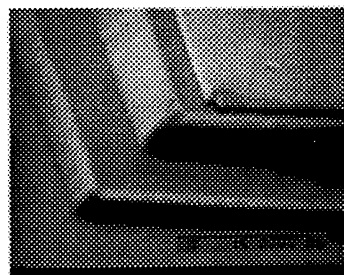
Fig 2. Properly biased pattern. (Metal with two steps mesa etching) No electrochemical etching is observed

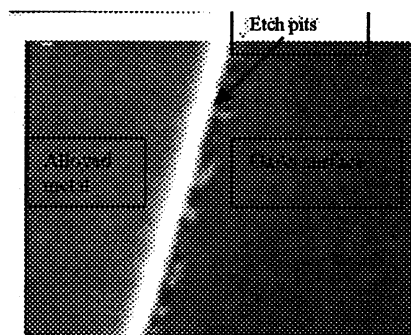
A decrease in the device saturation current can be observed whenever a surface treatment is applied, while the magnitude of the effect depends on the chemical composition of the solution. Figure 3 shows the enhanced consumption of the GaAs in the vicinity of the alloyed stack metal.

Fig3: etching pits after 2 cycles of surface treatment with dilute BHF

Table 1 shows a high sensitivity to chemical composition of the solution, so if a surface treatment of oxide removal (in the presence metal substance) is necessary the use of dilute HCl solution is preferable because it yields with the smallest damage.
