## Elimination of Yield Loss Due to Rogue Polyimide Vias

David Crawford, Yelda Recsei, Manjeet Singh, Dragana Barone, Samuel Mony, and Shiban Tiku

Skyworks Solutions, Inc.  
2427 West Hillcrest Drive, Newbury Park, CA 91320  
Email: [david.crawford@skyworksinc.com](mailto:david.crawford@skyworksinc.com)  
(805) 480-4360

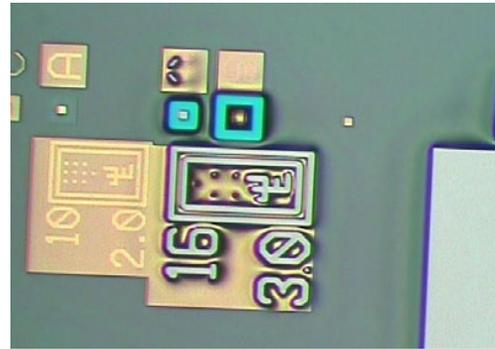
A previously interesting and anomalous photo pattern image, Fig. 1 (from the initial qualification of the new photoresist for the polyimide via layer), provided the basis for the next promising theory. It appeared that the polyimide was contracting during the plasma etch, when the resulting feature was an isolated island. Discussions centered on the physical properties of the polyimide: was the polymer contracting due to film stresses being released or was the film improperly cured, adversely enhancing its behavior to the plasma etch environment.

Figure 1 - Apparent contraction of Polyimide

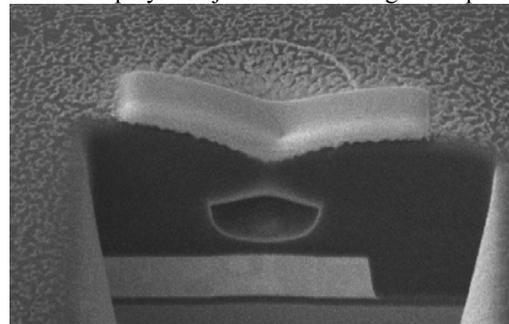
Fortuitously another focused ion beam (FIB) micrograph emerged, Fig. 2, which provided the next positive link in the investigation. The cross-section displayed a partially etched polyimide via with the photoresist virtually closed off. The width of the polyimide via indicated that the photoresist was initially open and sized correctly. During the course of the plasma etch, the photoresist flowed itself closed. The new resist does indeed seem to play a major role in this rogue via problem.

Figure 2 - Photoresist flow during Polyimide Etch

Upon further investigation, it was discovered that the wafer chuck was badly worn to the point that the wafer was not making uniform contact. The lower electrode (which includes the chuck) was replaced and the polyimide etch tests rerun. The wafer temperatures were reduced and the rogue vias were no longer present. The root-cause of the rogue vias had finally revealed itself. The necessary testing for the etch tools to monitor the chuck cooling was immediately included in the PM procedures.
