Enhanced visual performance in GaN HEMT technology

Kai-Sin Cho, Yue-Ting Lin, Wei-Chou Wang, Jhih-Han Du, Forrest Cho, and Walter Wohlmuth

WIN Semiconductors Corp., No. 35, Technology 7th Rd., Hwaya Technology Park, Kuei Shan Hsiang, Tao Yuan Shien, 333, R.O.C.

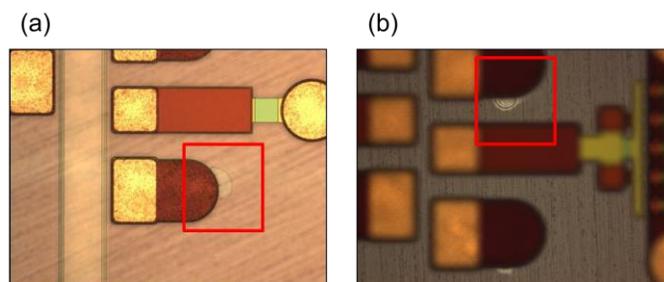
Fig. 1. Microscopic pictures of (a) front-side nitride crack and (b) back-side discoloration.

Before enhancing the visual yield, one needs to know the dominant factors that cause yield loss. According to human visual inspection (HVI), there are two major failure symptoms called front-side (FS) nitride crack and back-side (BS) discoloration. These two visual abnormalities are experimentally demonstrated in (0001)-oriented AlGaIn/GaN HEMT devices.

Figure 1 shows the typical optical microscope images of both failures. By changing thermal treatment temperature and

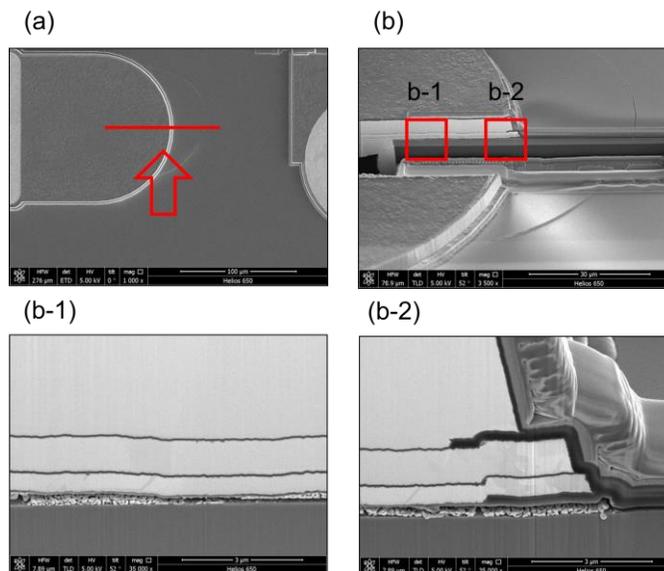
Figure 2 shows the SEM and FIB studies of the 1st failure mode called front-side nitride failure. Obviously, this nitride crack is because of metal erosion after back-side ICP etching followed by subsequent thermal processing. Figure 3 displays the possible failure mechanism caused by the back-side ICP process. Due to our hypothesis, we could reduce this anomaly effectively by changing to a more robust front-side bottom metal for the substrate via etch stop.

Fig. 2. (a) SEM image of front-side nitride crack failure. The red arrow indicates the FIB analysis direction. (b) FIB image of the front-side failure. The etched metal causes the nitride crack shown in zoomed-in (b-1) and (b-2) pictures

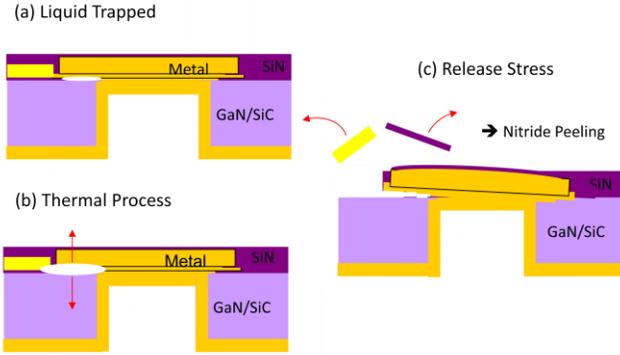
Fig. 3. The animated pictures describe the origin of the front-side nitride failure mechanism. (a) Liquid is trapped in the vacancy caused by the back-side ICP etch process. (b) Phase transition from liquid to gas occurs due to subsequent thermal processes. (c) A nitride crack forms to relieve stress.

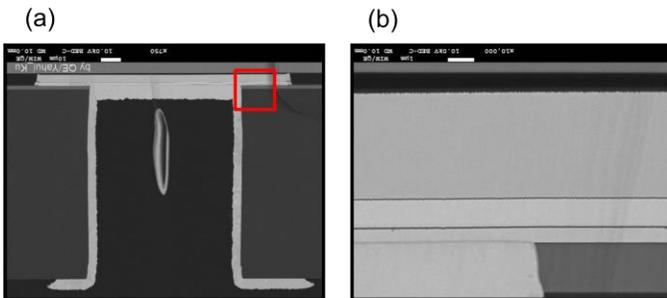
Fig. 4. (a) Cross-section image of the revised front-side bottom metal for back-side ICP etching. (b) Zoomed-in image

showing the robust profile of back-side to front-side metal contact with no vacancy.

According to statistical data listed in Table 1, the increased yield is enabled by a bottom metal change for the front-side contact to the back-side via. By changing the bottom metal layer as shown in Fig. 4, one can reduce the metal undercut and liquid trapped during back-side manufacturing. Consequently, front-side nitride thermal stability becomes better due to a more robust metal. The statistical data confirms our prediction of the underlying mechanism responsible for front-side nitride crack.

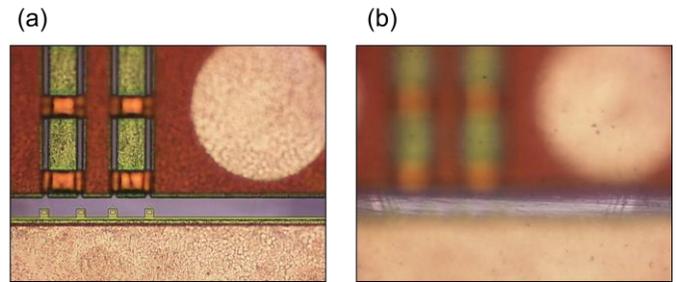
On the other hand, the observed 2nd failure mode called back-side discoloration anomaly is proven to be a back-side metal adhesion issue. As shown in Fig. 5, we need to focus very “deeply” to get clear images when inspecting the front-side of the wafer. This implies the discoloration symptom should NOT happen on the front-side surface. Therefore, we performed a cross-sectional polish (CP) of this odd discoloration. Based on the CP images shown in Fig. 6, the root cause of discoloration anomaly is due to the existence of a delaminated interface between the substrate and back-side seed layer. In addition, the failure rate of this 2nd failure mode increases with increasing operation temperature and the rainbow-like discoloration becomes pronounced after harsh thermal treatment. For GaN high-power and high-temperature application purposes, we need to provide sufficient back-side metal/substrate adhesion in our AlGaIn/GaN device.

Fig. 5. Microscopic pictures of the back-side discoloration. The images are focused on (a) front-side surface and (b) back-side substrate.

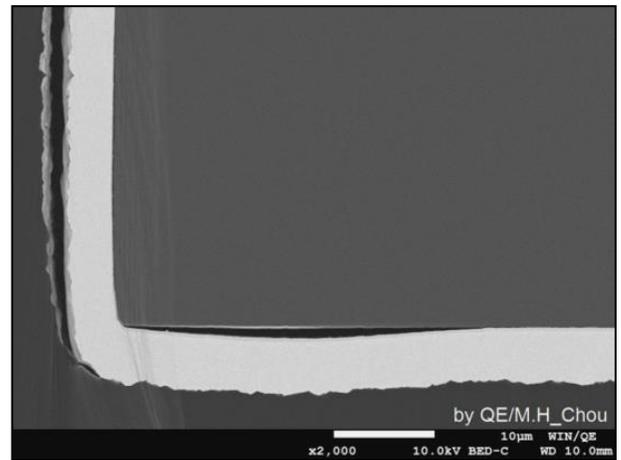
Fig. 6. CP image of the discoloration. The back-side discoloration is due to optical diffraction from the delaminated interface.

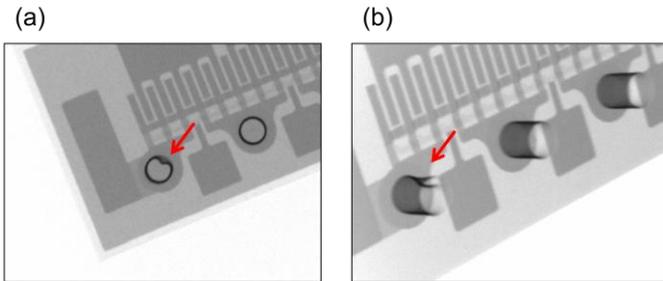
metal delamination theory as shown in Fig. 7. Theoretically, if the surface is not clean enough, the delaminated interface would occur not only on back-side substrate surface but also in the ICP-etched substrate via. With the 3D X-ray imaging study shown in Fig. 8, the back-side metal distortion in the via is verified to occur in the sample exhibiting discoloration. In addition, tilted X-ray images can even indicate the weak location. By comparing the CP and X-ray investigations our model can explain the origin of the discoloration. Based on our study, the back-side surface cleanliness after via etch is the key for metal adhesion. Due to the remaining, stubborn byproduct after ICP etch, one cannot easily get a clean surface prior to BS metal deposition. As a result of this study, WIN implemented a suitable clean solution to remove the byproduct and the discoloration symptom can be suppressed significantly. Table 2 shows the apple-to-apple comparison of different clean solutions. It's obvious that "SO₄²⁻-based chemical" has a higher visual yield after high-temperature bake.

Fig. 8. (a) X-ray image of the distorted metal after 1 hour, 350 °C bake. (b) Tilted X-ray image showing the 3D geometry of the delaminated metal.
