Enhanced Visual Performance in GaN HEMT Technology

Kai-Sin Cho, Yue-Ting Lin, Wei-Chou Wang, Jih-Han Du, I-Te Cho, and Walter Wohlmuth

WIN Semiconductors Corp., No. 35, Technology 7th Rd., Hwaya Technology Park, Kuei Shan Hsiang, Tao Yuan Shien, 333, R.O.C.

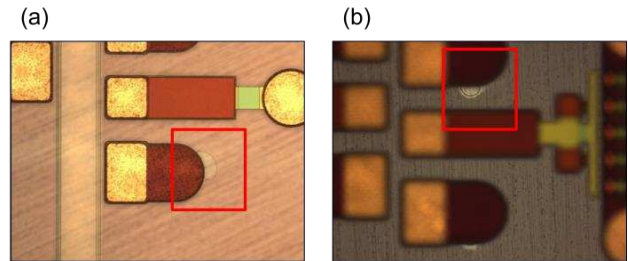
Fig. 1. Microscopic pictures of (a) front-side nitride crack and (b) back-side discoloration.

Before enhancing the visual yield, one needs to know the dominant factors that cause yield loss. According to human visual inspection (HVI), there are two major failure symptoms called front-side (FS) nitride crack and back-side (BS) discoloration. These two visual abnormalities are experimentally demonstrated in (0001)-oriented AlGaIn/GaN HEMT devices.

Figure 1 shows the typical optical microscope images of both failures. By changing thermal treatment temperature and

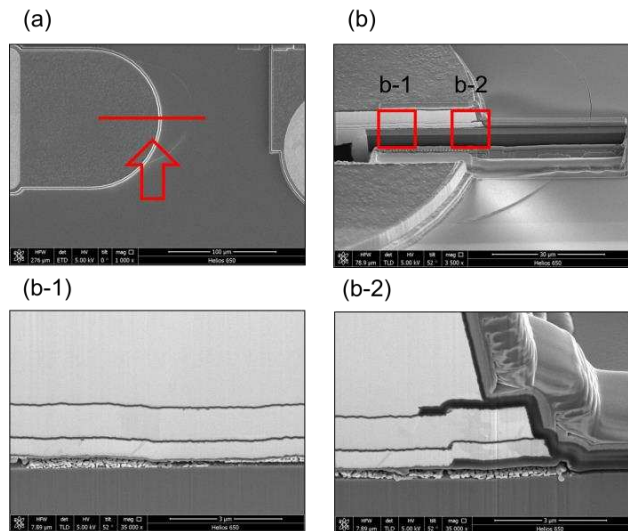
Figure 2 shows the SEM and FIB studies of the 1st failure mode called front-side nitride failure. Obviously, this nitride crack is because of metal erosion after back-side ICP etching followed by subsequent thermal processing. Figure 3 displays the possible failure mechanism caused by the back-side ICP process. Due to our hypothesis, we could reduce this anomaly effectively by changing to a more robust front-side bottom metal for the substrate via etch stop.

Fig. 2. (a) SEM image of front-side nitride crack failure. The red arrow indicates the FIB analysis direction. (b) FIB image of the front-side failure. The etched metal causes the nitride crack shown in zoomed-in (b-1) and (b-2) pictures.

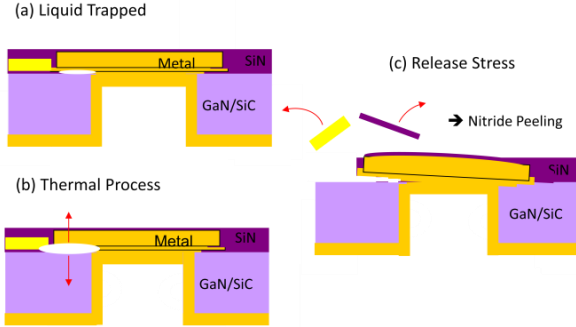
Fig. 3. The animated pictures describe the origin of the front-side nitride failure mechanism. (a) Liquid is trapped in the vacancy caused by the back-side ICP etch process. (b) Phase transition from liquid to gas occurs due to subsequent thermal processes. (c) A nitride crack forms to relieve stress.

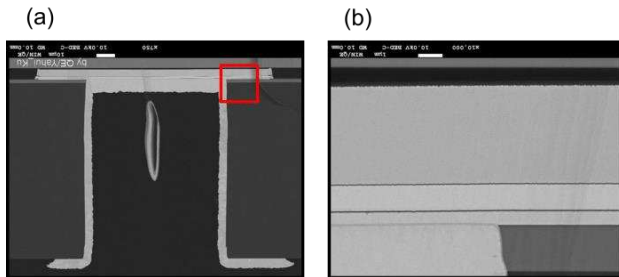
Fig. 4. (a) Cross-section image of the revised front-side bottom metal for back-side ICP etching. (b) Zoomed-in image

showing the robust profile of back-side to front-side metal contact with no vacancy.

According to statistical data listed in Table 1, the increased yield is enabled by a bottom metal change for the front-side contact to the back-side via. By changing the bottom metal layer as shown in Fig. 4, one can reduce the metal undercut and liquid trapped during back-side manufacturing. Consequently, front-side nitride thermal stability becomes better due to a more robust metal. The statistical data confirms our prediction of the underlying mechanism responsible for front-side nitride crack.

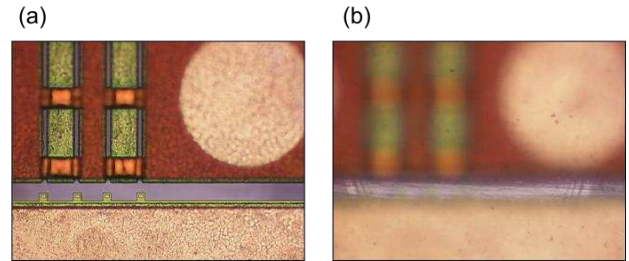
On the other hand, the observed 2nd failure mode called back-side discoloration anomaly is proven to be a back-side metal adhesion issue. As shown in Fig. 5, we need to focus very “deeply” to get clear images when inspecting the front-side of the wafer. This implies the discoloration symptom should NOT happen on the front-side surface. Therefore, we performed a cross-sectional polish (CP) of this odd discoloration. Based on the CP images shown in Fig. 6, the root cause of discoloration anomaly is due to the existence of a delaminated interface between the substrate and back-side seed layer. In addition, the failure rate of this 2nd failure mode increases with increasing operation temperature and the rainbow-like discoloration becomes much more pronounced after harsh thermal treatment. For GaN high-power and high-temperature application purposes, we need to provide sufficient back-side metal/substrate adhesion in our AlGaIn/GaN device.

Fig. 5. Microscopic pictures of the back-side discoloration. The images are focused on (a) front-side surface and (b) back-side substrate.

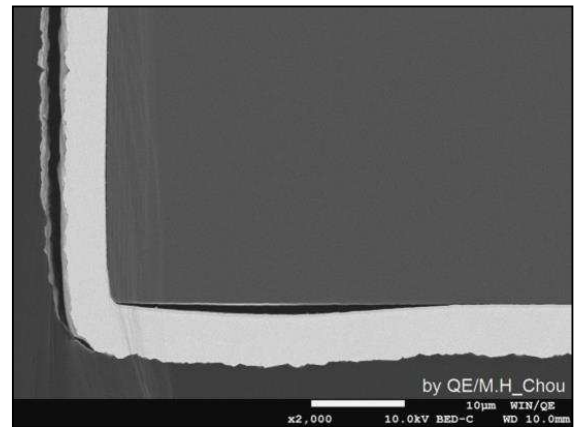
Fig. 6. CP image of the discoloration. The back-side discoloration is due to optical diffraction from the delaminated interface.

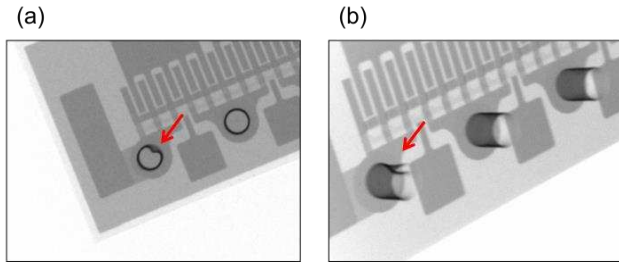
Fig. 8. (a) X-ray image of the distorted metal after 1 hour, 350 °C bake. (b) Tilted X-ray image showing the 3D geometry of the delaminated metal.

In order to understand the whole picture of the BS discoloration mechanism, we have come out with a back-side metal delamination theory as shown in Fig. 7. Theoretically, if the surface is not clean enough, the delaminated interface would occur not only on back-side substrate surface but also in the ICP-etched substrate via. With the 3D X-ray imaging study shown in Fig. 8, the back-side metal distortion in the via is verified to occur in the sample exhibiting discoloration. In addition, tilted X-ray images can even indicate the weak location. By comparing the CP and X-ray investigations, our model can explain the origin of the discoloration. Based on our study, the back-side surface cleanliness after via etch is the key for metal adhesion. Due to the remaining, stubborn byproduct after ICP etch, one cannot easily get a clean surface prior to BS metal deposition. As a result of this study, WIN implemented a suitable clean solution to remove the byproduct and the discoloration symptom can be suppressed significantly. Table 2 shows the apple-to-apple comparison of different clean solutions. It's obvious that "SO₄²⁻-based chemical" has a higher visual yield after high-temperature bake.
