# Improving Root Cause Analysis Accuracy Using Advanced Sensor Trace Analytics

## WAFER EDGE LOW YIELD CASE STUDY

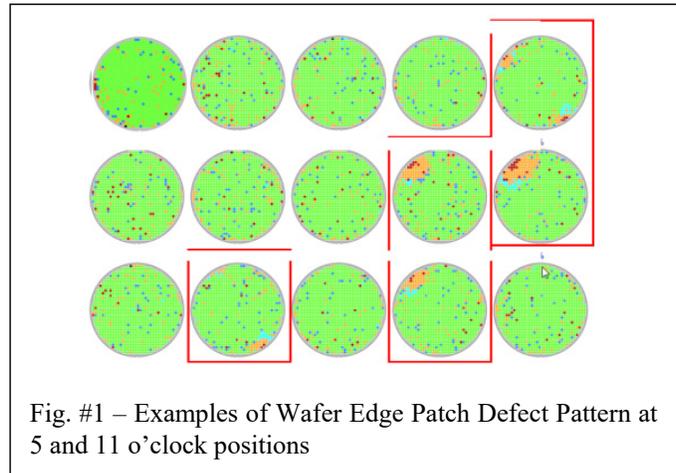
In this case study, the manufacturer experienced unusually high yield loss in three wafer lots. Over 30% of the wafers suffered from low yield patches at the 5 and 11 o'clock positions on the wafer edge. Yield loss was up to 11% on each affected wafer (see Fig. #1).

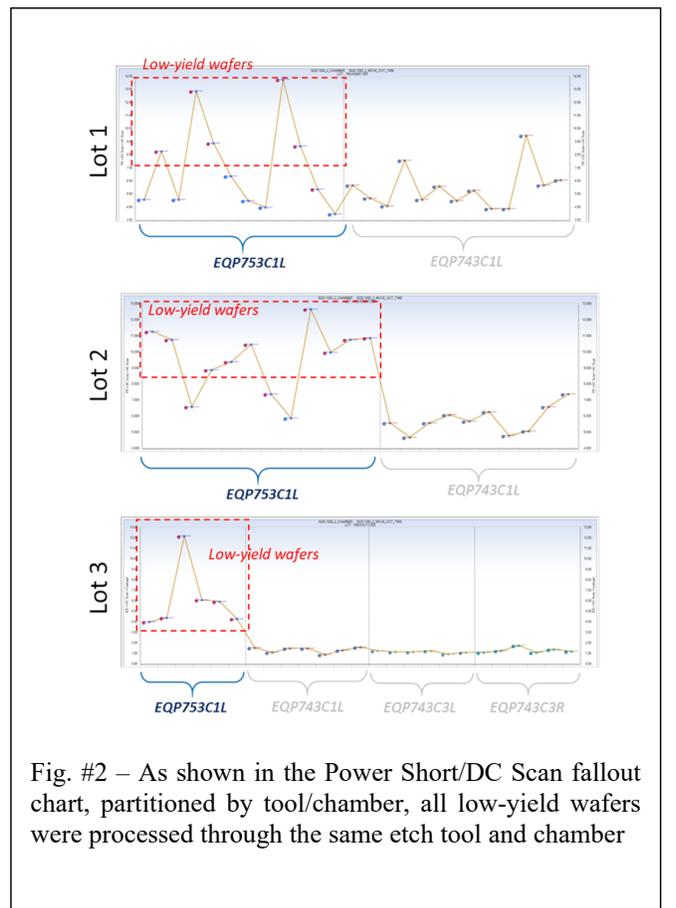
In the first step of analysis, chamber commonality was performed using an existing YMS analytic software tool. The software tool analyzed the process data against the yield patterns and suggested that the issue was isolated to a process step in the left chamber of an etch tool. In Fig. #2, fallout

charts from the YMS software show that all low-yield wafers with this specific yield pattern were processed through the same chamber of the same tool (Left chamber 1 of etch tool 753).

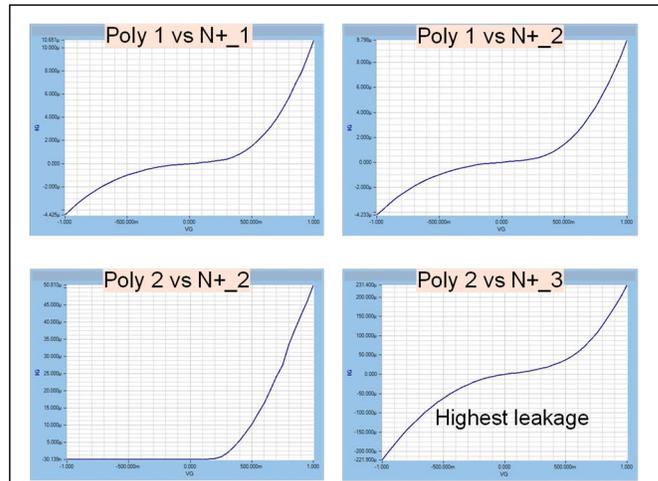
Fig. #3 – AFP analysis confirmed poly to N+ leakage at EMMI hot spot location

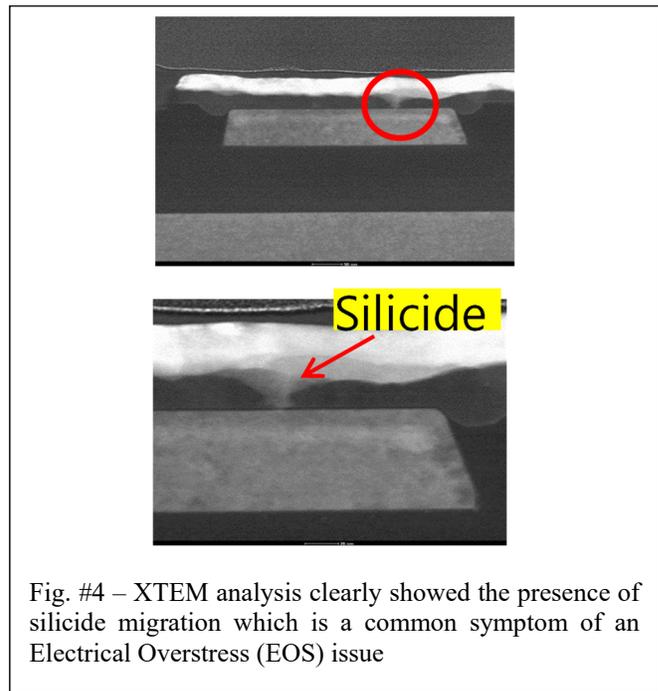
- 1) Electrical analysis on a failed die to validate leakage with IV curve against a good die – Result: significantly high leakage was observed
- 2) EMMI emission fault isolation to localize the defect location within the die – Result: Failure hot spots identified
- 3) Physical deconstruction of the affected die down to the contact layer – Result: No anomalies observed on the metal layers
- 4) AFP nanoprobing analysis on “transistor” level – Result: Confirmed Poly to N+ leakage at EMMI hot spot locations (see Fig. #3)
- 5) High Beam Contrast inspection to confirm leaky poly – Result: No anomalies observed
- 6) Cross-sectional TEM examination of the leaky poly – Result: Identified silicide migration towards gate oxide (see Fig. #4)

Silicide migration is a symptom of Electrical Overstress (EOS) which could suggest arcing during the manufacturing process. With this information, the engineer became more confident in the hypothesis.

Fig. #4 – XTEM analysis clearly showed the presence of silicide migration which is a common symptom of an Electrical Overstress (EOS) issue

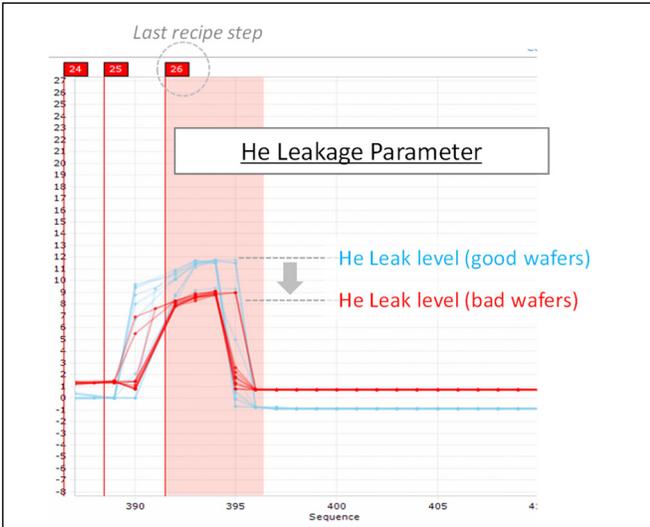
With the help of the trace analytic software solution, the engineer was able to effortlessly analyze all sensor traces and identified a list of potential candidates (at the parameter level) as possible root causes within minutes. After examining some of the top candidates, the engineer identified the Helium (He) Leakage parameter to be the main root cause indicator of the problem. This parameter measures the level of Helium that is present between the wafer and the Electrostatic Chuck (ESC) platform. The engineer noticed that the measurements of this specific parameter from the low yield wafers were consistently lower than those from the high yield wafers during the last step of the etch process (see Fig #6). This indicates the wafers were not properly decoupled from the ESC platform at the end of the etch process which likely resulted in Plasma Induced Defects (see Fig #7).

Fig. #6 – Trace Analytic software shows that Helium Leakage level at the last recipe step to be lower for low-yield wafers

importantly, both parameters are now included as part of the critical parameter list in FDC for monitoring, which should prevent the re-occurrence of the same issue.

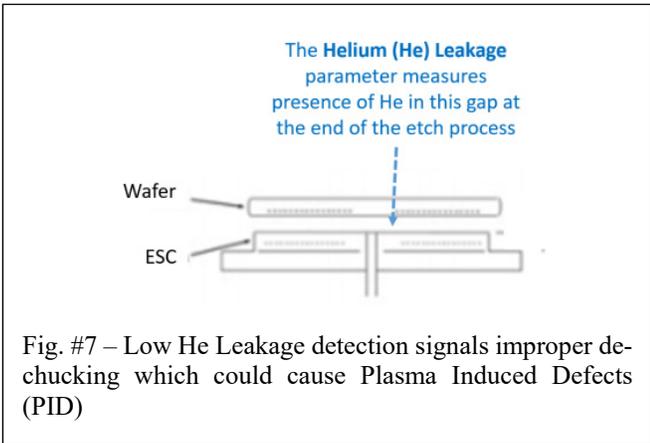
Fig. #7 – Low He Leakage detection signals improper de-chucking which could cause Plasma Induced Defects (PID)

With the confirmed root cause of a problematic ESC, the failed unit was replaced to correct the issue. More

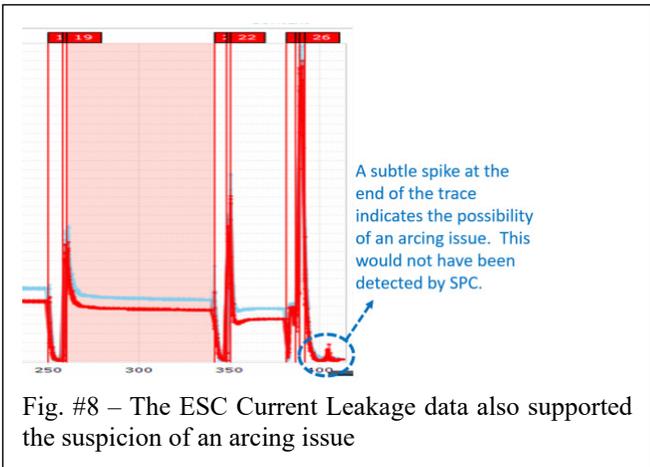
In addition, upon closer examination of the rest of the potential root cause candidates, the engineer discovered another parameter (an unmonitored parameter by FDC) with indicators which correlated strongly with the low-yield wafers. This parameter specifically measures the ESC Current Leakage, and the data from the low-yield wafers all showed a subtle spike at the end of the trace which indicates abnormalities at the end of the etch process (see Fig. #8). Under normal operation, this parameter should remain at zero at the end of the etch process. This subtle spike confirms the arcing suspicion supported by the early findings.

Fig. #8 – The ESC Current Leakage data also supported the suspicion of an arcing issue
