Chemical Attack of a pHEMT Channel Due to Poor Passivation Coverage

Robert Waco, Corey Nevers, and Val Besong

Qorvo, Inc., 2300 NE Brookwood Parkway, Hillsboro, OR. 97124
e-mail: Robert.Waco@Qorvo.com, Phone: +1 503-615-9439

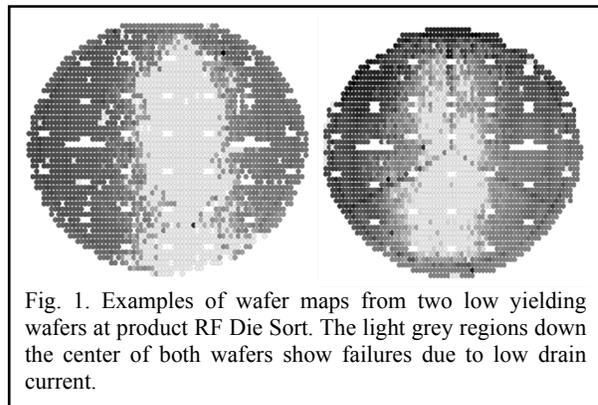
This first sign of a problem came from Product Engineering, where one of the first pre-production lots exhibited significant yield loss at RF die sort test. The failing parameter was a test of the output current from one of the amplifiers in the circuit, where regardless of the gate voltage applied, there was no output current. This implied something severe had happened to the device during manufacturing, likely to be defect related, not parametric.

Wafermaps from die sort test were generated and analyzed for patterns. Wafermaps are a way to view a parametric test data as a function of X, Y location on the wafer, see Figure 1. The yield loss had a peculiar pattern, thus assistance from Fab Yield and Integration Engineering was required. The team went to work determining where the failures originated in the manufacturing process. The yield loss pattern revealed failures concentrated in the center of the wafer, and often so severe, the entire wafer was impacted, see Figure 1.

Fig. 1. Examples of wafer maps from two low yielding wafers at product RF Die Sort. The light grey regions down the center of both wafers show failures due to low drain current.

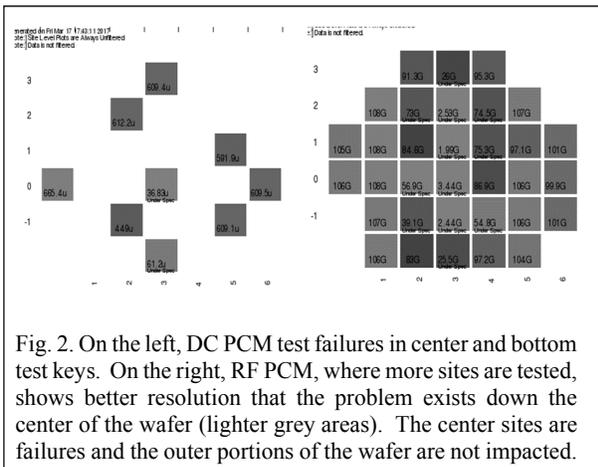
DC parameters are tested at nine PCM's on each wafer, first just after the FET ohmic contacts are formed and again at the end of the line. Failing sites revealed FETs exhibiting low drain current, high on-channel resistance, and positive Vp (Figure 2, left). Thirty-three sites are tested at RF PCM test step. This added resolution showed the similar failure pattern found at die sort. These failures were mainly low FT (Figure 2, right).

Fig. 2. On the left, DC PCM test failures in center and bottom test keys. On the right, RF PCM, where more sites are tested, shows better resolution that the problem exists down the center of the wafer (lighter grey areas). The center sites are failures and the outer portions of the wafer are not impacted.

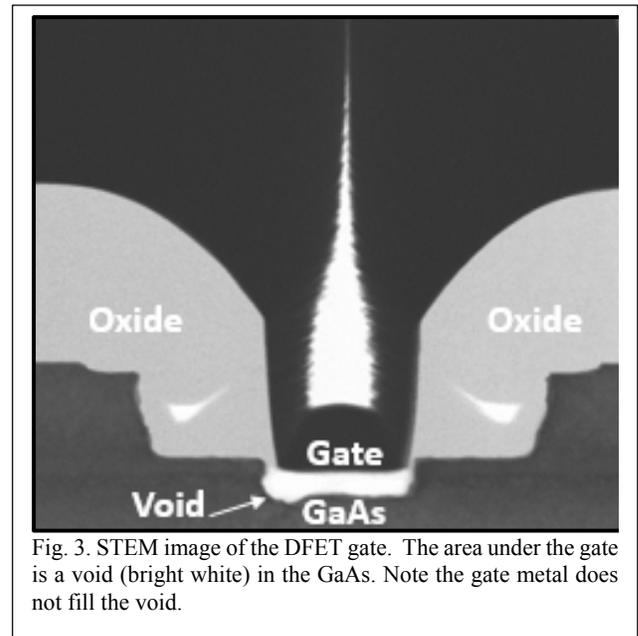
The STEM image in Figure 3, revealed a void under the gate, however the gate was not recessed into the void. Since the gate is deposited via a sputter process, the gate should conformally cover any topography. Therefore, the void in the Schottky contact, seemed to

form after the gate metal was deposited. Additional SEM cross sections were required to outline the scope of the erosion.

Fig. 3. STEM image of the DFET gate. The area under the gate is a void (bright white) in the GaAs. Note the gate metal does not fill the void.

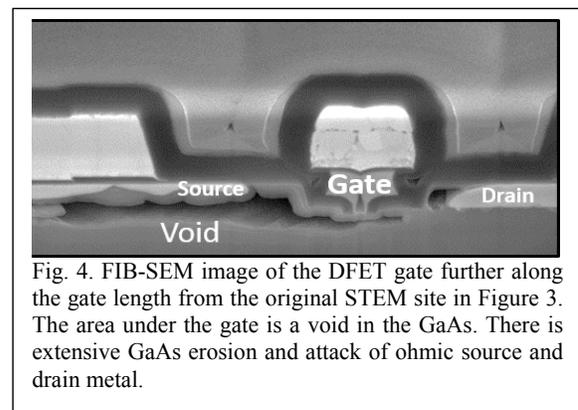
Additional FIB cuts were performed in systematic intervals along the gate width. This analysis showed more extensive GaAs erosion; not only under the gate but under the source and drain ohmic contacts. There was additional attack of the ohmic metal noted as well, see Figure 4.

Fig. 4. FIB-SEM image of the DFET gate further along the gate length from the original STEM site in Figure 3. The area under the gate is a void in the GaAs. There is extensive GaAs erosion and attack of ohmic source and drain metal.

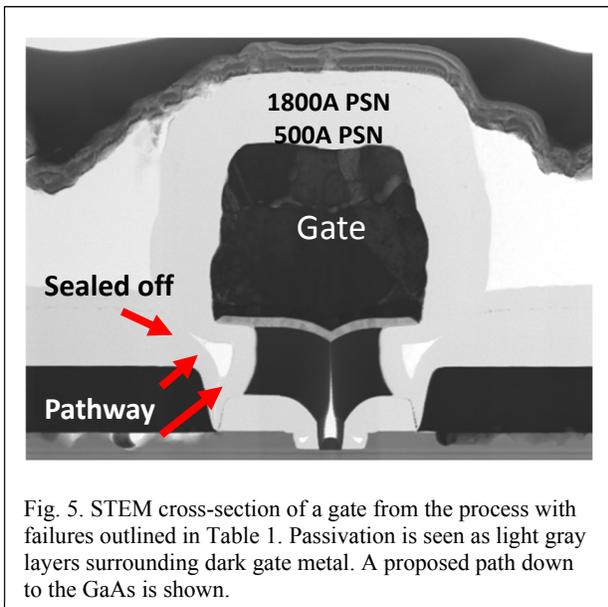
Fig. 5. STEM cross-section of a gate from the process with failures outlined in Table 1. Passivation is seen as light gray layers surrounding dark gate metal. A proposed path down to the GaAs is shown.

After the side by side comparison was completed, it became clear that the 500A of PSN deposited post ohmic formation, was not robust to the subsequent processing steps. Most likely, the topography of the FET causes seams in the PSN which allowed the passage of processing chemistry. The failure model can be visualized with the aid of a STEM cross-section seen in Figure 5, where a Transmission mode image shows the passivation surrounding the gate of the transistor. The passivation here is a stack of 500A + 1800A deposited after numerous steps shown in Table 1. The water and solvent steps can leave some chemistry in the PSN seams formed at the 500A dep. The seams are due to high topography (V shaped troughs) and a thin PSN layer. Water and the solvents trapped combine to form carboxylic acid, which may further attack the passivation cracks. Combine this with numerous water and solvent modules, a continual attack of the PSN and the underlying GaAs occurs. It was already shown that water alone does not cause the degradation, so it seems that both water and solvent cycles are critical.

The ultimate fix to the attack of the FETs was to mimic the “sister” process through these steps, but to also add some margin. The process change was to deposit the final stack of 500Å + 1800Å but all together post ohmic contact formation. Keeping with an existing stack thickness target allowed the use of existing etch recipes from the “sister” process.
