Mechanism and Resolution of Implant Induced ESD Damage in GaAs IC Processing

Lam Luu-Henderson, Mehran Janani, John Bonk, Steve Canale, Mark Borek
Skyworks Solutions, Inc. 2427 Hillcrest Drive, Newbury Park, CA. 91320
Lam.Luu@Skyworksinc.com, (805) 480-4339

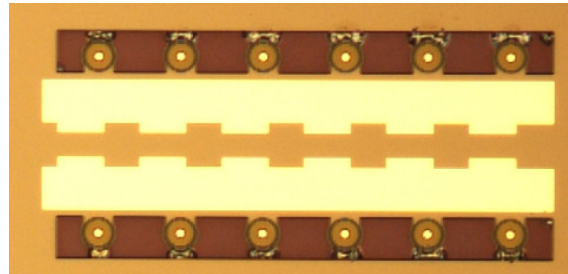
Typically, the isolation implant process is introduced early in the GaAs processing flow with no or very low density of metal contacts on the surface of the GaAs wafers. This is to avoid any potential yield impact caused by ESD damage as a result of the build-up of charge on the metal and wafer surface during the implant step. In circumstances where metal contacts are necessary prior to implant, the size and area of each contact must be minimized to prevent excessive ESD failures. A severe example of this occurred during a new HBT technology node development where the combination of ohmic metal contacts in an HBT array passivated by protective SiN_x (nitride) layer and coated with photo resist prior to implantation created the critical environment for the tremendous damage caused by electrostatic discharge. These ESD defects shown in Figure 1 contributed to both visual and probe failures and accounted for about 0.5% yield loss. The visual failure was captured by the inline optical (August tool) inspection and the probe yield loss was caught at the functional leakage test.

Figure 1. ESD defects on HBT transistor array

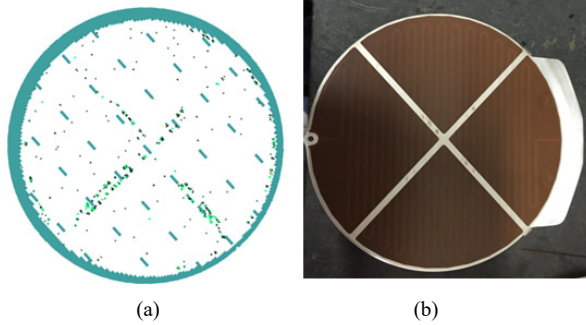
Wafers passivated with unpatterned photo resist and nitride films were observed to have the most severe ESD defects. Wafers that were cycled through the implanter without receiving any implant processing did not exhibit any ESD damage which implied the charging of wafers occurred during the implant process. Furthermore, reducing the implant beam current seemed to have a direct impact to the severity of the ESD damage and the failures appeared to be area dependent impacting the larger metal features considerably more than the smaller, isolated ones. Interestingly, in extreme cases, the ESD damaged structures on the wafer followed a cross pattern as displayed in Figure 2. This pattern was later identified to mirror the grounding path of the electrostatic chuck (ESC) on the EATON/Axcelis 8250 ion implanter system. All of the above findings were critical in explaining how the implanted charges were distributed across the wafer, how excess charges built up at certain locations on the wafer and how these charges dissipated through the ESC chuck to ultimately generate these devastating failures.

Figure 2(a) Yield map with cross-hair ESD failures (b) the Implanter ESC chuck ground path in a cross and ring pattern with the grounding pin to the left of the chuck.

The EATON/Axcelis 8250 implanter ESC chuck is uniquely designed for GaAs processing with the chuck divided into four equal quadrants so that the polarity of these sections can be reversed to allow for better release of the wafer after the implant process. The four sections of this ESC are laid out in a cross configuration within the outer edge ring as seen in Figure 2(b). The entire surface of the ESC is coated with an insulating polymer except for the cross-hair and outer ring areas which are used to ground the substrate through grounding pin as shown in the circular pinhole to the left of Figure 2(b).

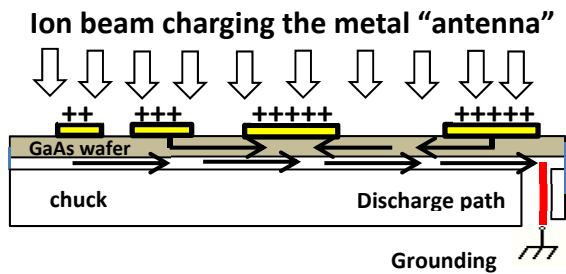
During implant, the wafer is in constant contact with the grounding pin to ensure proper dissipation of the accrued charge. Throughout the implant process, positive He⁺/He⁺⁺ ions are targeted at the wafer resulting in positive charges accumulating on the surface of the photoresist and conducting metal surface. However, these metal contacts are encapsulated by the nitride and photo resist films with no means for excess charges to dissipate. The only path for this charge build-up to be released is through the grounded and un-insulated cross pattern and outer ring of the ESC chuck. This naturally increases the concentration of charges on the wafer metal features along the cross pattern and outer ring areas resulting in higher probabilities of ESD damage in those regions. This failure mechanism is illustrated in Figure 3 and explains the locations of the yield loss as well as the numbers of finding from the experiments mentioned above.

Figure 3. Illustration of the charge distribution across the wafer during implantation and the dissipation path through the grounded channels of the ESC chuck.

Specifically, this theory supports the observation that higher implant beam currents will result in higher amount of charge bombarding the wafer which then becomes congested around the grounding regions during implant and subsequently leads to higher ESD failures. In addition, this would suggest a direct relationship between the exposed metal surface area on the wafer during implant and the yield impact due to ESD damage. With ESD being dependent on the size of the contact area, this would account for the commonly observed defect map where the smaller, isolated transistors are unaffected by ESD while the larger arrays of HBT are more prone to the effects of electrical discharge as evidenced in the optical inspection yield map in Figure 4.

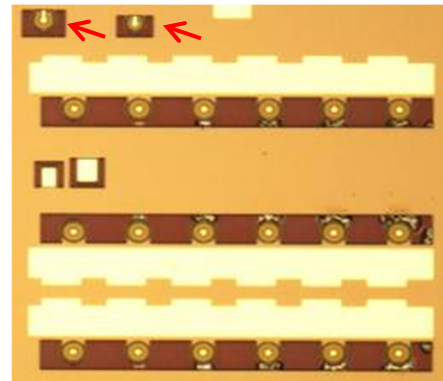
Figure 4. ESD defects on HBT transistor array and lone transistor without ESD failure.

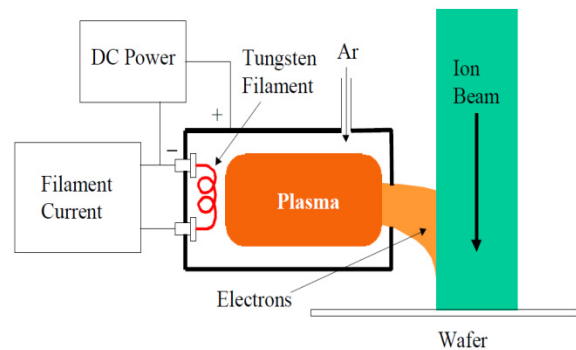
Figure 5. Diagram of the Implanter with E-Shower.

One industry-established method in addressing implant-related ESD damage is to incorporate an electron shower (E-shower) capability into the implant process [1]. This additional filament integrated into the hardware essentially floods the ion beam with a surge of negative charge that neutralizes the positive He⁺/He⁺⁺ ions prior to implantation as displayed in Figure 5.

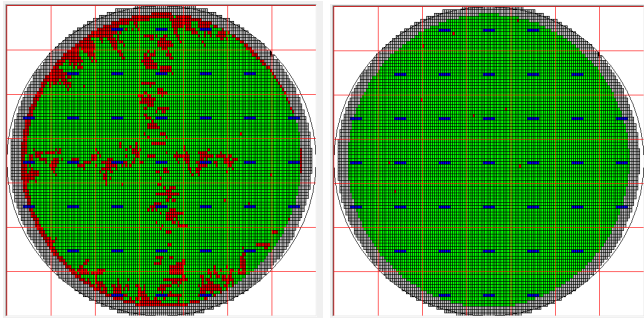
To simulate an extreme ESD-prone condition, GaAs wafers were deposited with contact metal then coated with a blanket sheet of photo resist followed by a coat of Silicon Nitride. These wafers were then implanted with and without the E-shower beam enabled and the results are displayed in Figure 5. Wafer processed with E-shower showed no symptom of ESD in comparison to the non E-shower wafer exhibiting an extreme case of ESD damage.

Figure 6. Yield maps of wafers without and with E-Shower during implant.

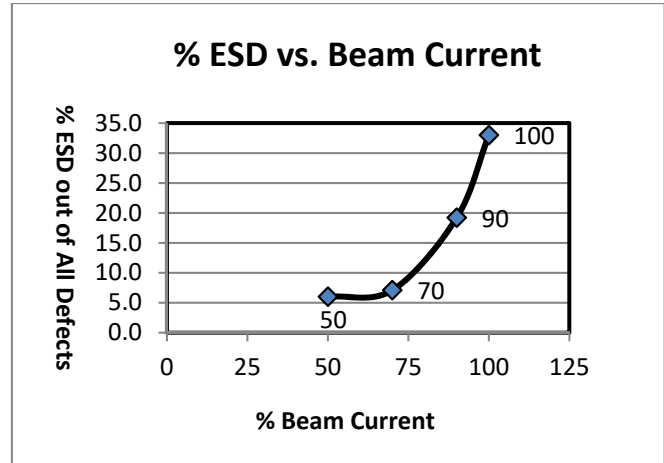
After iterations of Design of Experiment (DOE), the ideal E-shower process conditions were determined for the EATON/Axcelis 8250 implanter which allow for optimal isolation, cycle time and major improvement to the ESD yield loss. As with any tool upgrade, however, this can be a costly undertaking and in the present state of lean manufacturing, equipment modification is not commonly feasible. Therefore, alternative process methods are generally developed to mitigate and contain these types of yield loss. In this instance, one approach that was explored was reducing the implant beam current which ultimately limits the density of charge striking the wafer and thus decreasing the amount of charge collected at the contact metal in the cross-ring region. As expected, the level of the ESD damage is consistent with the magnitude of the implant beam current which is summarized in Figure 7 depicting a beam current DOE for a given implant process. In this experiment, the implant beam current was varied between 50% and 100%. The resulting implanted wafers were inspected immediately after implant on the August inspection tool and the number of ESD failure was compared against all defects that were detected. There was clear

correlation between the beam setting and the amount of ESD loss. The degree of charging on the wafer as a function of the implant current was thoroughly studied by the EATON Corporation which first developed the E-shower capability back in the 1980's [1].

Figure 7. Plot of the % ESD damage out of all visual defects versus the implanter beam current for a given isolation recipe.

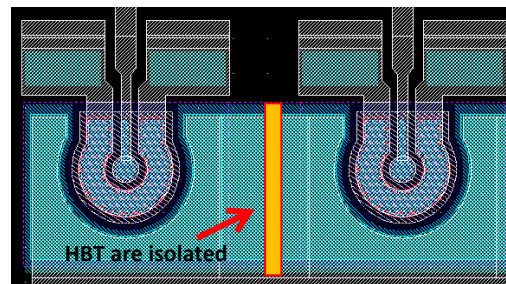
Figure 8. Layout showing the HBT segments are disconnected which help reduce charge buildup along the metal surface.

Another potential solution, although at times challenging is to redesign the layout of the device structures to isolate them electrically, keeping the overall surface area to a minimum and reducing the probability of charge build up on metal contacts which in turn can result in ESD. An example for this layout is showed in Figure 8 in which the transistors in the array are disconnected electrically and with smaller conducting surfaces, will acquire less charge and therefore less opportunities of an electrical discharge. This change can be implemented through etch, isolation process or altering the subsequent interconnecting metal.

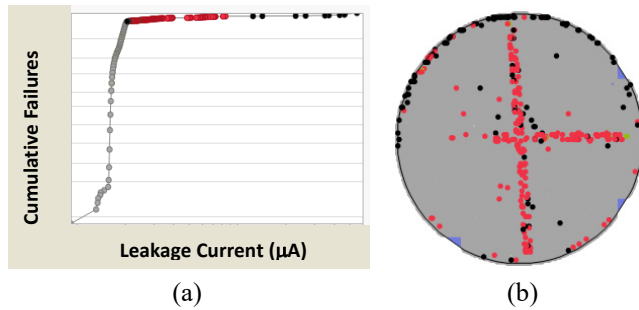
have gone undetected. This test involved increasing the bias voltage in order to catch marginal or leaky dies. The failures uncovered by this method were later confirmed to be ESD induced which proved that this test is a good filter for this type of defects. Figure 9 depicts the leakage failure and resulting failed dies which again followed the cross and outer ring pattern consistent with the implant ESD damage.

Figure 9(a) Example of extra leakage test detecting ESD failures (b) Yield map showing failed dies in the cross and ring pattern.

Finally, to further prevent additional escapes, a combination of visual inspection and probe test were implemented. Particularly, 100% final outgoing August inspection was used to screen out visual ESD failures while a special leakage test was applied to the standard functional probe test in order to catch any weakened die that might
