Fabrication Process Induced ESD Damage of MIM Capacitors on a 0.15um pHEMT Process

Robert Waco, Rose Emergo, Steve Brockett, Tertius Rivers, Yiping Wang

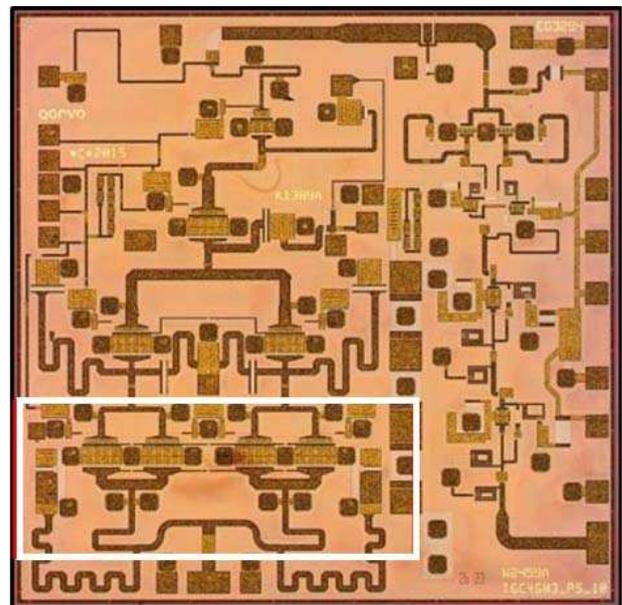
Figure 1: Optical image of a failing die. The area in the box shows the location of the final stage of the PA.

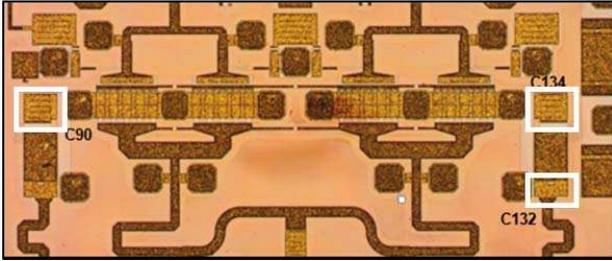
Figure 2: Partial optical image of a representative die showing the locations of the shorted capacitors (rectangles) obtained during liquid crystal analysis.

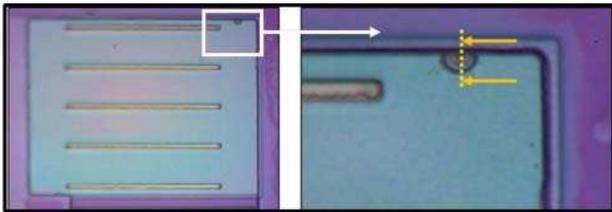
Figure 3: Optical images of the shorted capacitor C134 on a die showing the ESD-like damage (box). The dashed line shows the direction of FIB cross-section while the arrows show the direction of view.

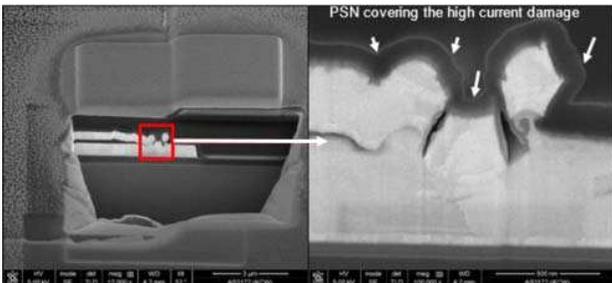
Figure 4: FIB cross-section of the ESD-like damage on capacitor C134 of a die (box). Note that the PSN layer is covering the high current damage completely suggesting that the ESD event occurred during the fabrication process, not at die sort or failure analysis.

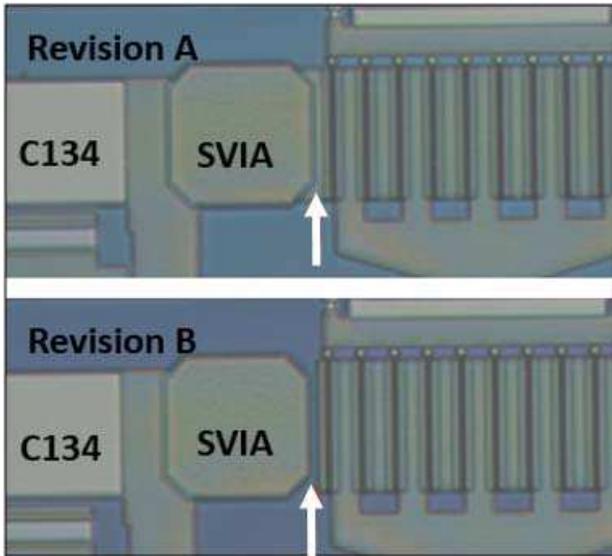
Figure 5: Optical images showing the bottom plate of the capacitor C134 is connected to the source of a DFET in version A, while the redesigned version B, the metal connection is removed. The capacitor is connected to ground through an SVIA.

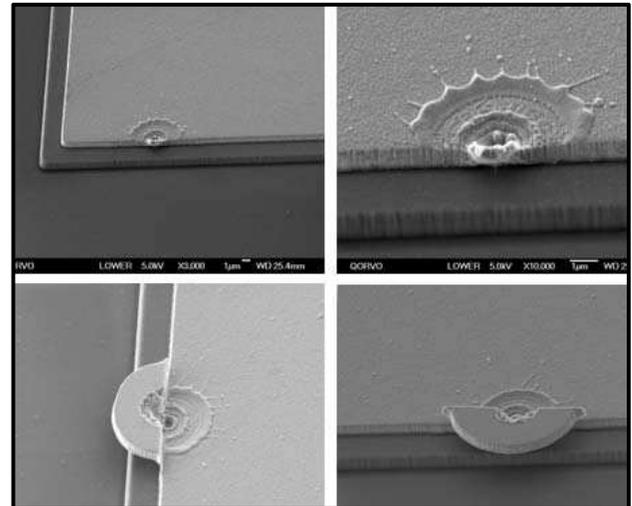
Figure 6: SEM images of the ESD damage on capacitors from a version A inspection. Note the remnants of the field metal layer are fused by arcing to the top plate of the capacitor.

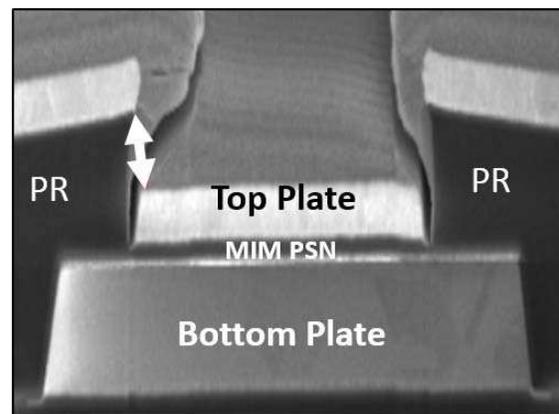
Figure 7: FIB cross section of the MIM capacitor prior to lift-off. The arrow indicates where the ESD event would create arcing between the top plate of the capacitor and the field metal prior to lift-off. PR is the photo resist.
