Reduction of Capacitor Metal Defect Formation in High Volume Manufacturing

Sarah Mason, PhD

Keywords: HBT, Capacitor Defects

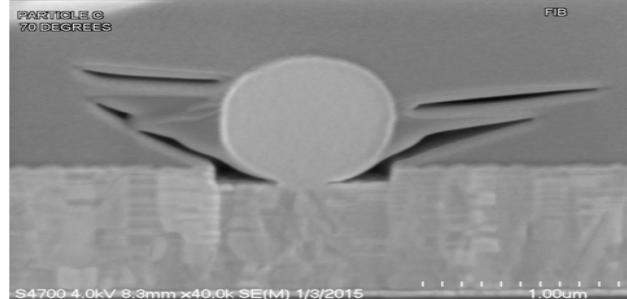
Gold ‘spitting’ [3] during the evaporation process is the most common cause of defect formation. Gold layer defects are typically caused either by light element contamination or by thermal shorting of the crucible liner to the water cooled copper hearth. When either of these issues occurs, increased e-beam power is required to maintain the deposition rate. Sharp fluctuations in power and/or rate are an indicator of

the Au source ejecting liquid droplets which form spherical nodules in the film.

Nodule defects in the film stack also form when gold evaporates from the outside walls of the crucible liner. This can happen for several reasons; the source material is prepared improperly, if the Ta amount is off target, or if gold build up from the surrounding hearth falls into the pocket with the crucible. Increased power for the same deposition rate is a sign that one of these events has occurred. These types of nodule defects are spherical in shape. They vary in size however; the majority of the nodules generated in an excursion event are under one micron in diameter.

Figure 1- SEM cross-section of an Au nodule formed in a ‘spit event’ the last 20nm of deposition.

While residual light element contamination in the source material is unavoidable, the addition of tantalum to Au each time it is replenished prevents it from causing spits. For this to be effective tuning the Ta to Au composition ratio is vital. Each evaporator runs a multitude of processes, which require the source materials to be replenished at irregular intervals. It was found that when the ratio becomes too low, the likelihood of a high particle count increases (Fig 5).

Adding Ta to Au to control spitting increases source preparation overhead. It is critically important to remove the resulting TaC buildup from the outside of the crucible liner each time Au source material is replenished. Failure to remove the buildup will cause the gold to wick out of the crucible with the Ta resulting in Au being deposited from the outside of the crucible. It is necessary to add Ta each time the source is replenished to control the amount spent and available Ta for light element removal. The removal of the buildup and the handling procedures for replenishing the source materials needs to be documented in detail and strictly adhered to.

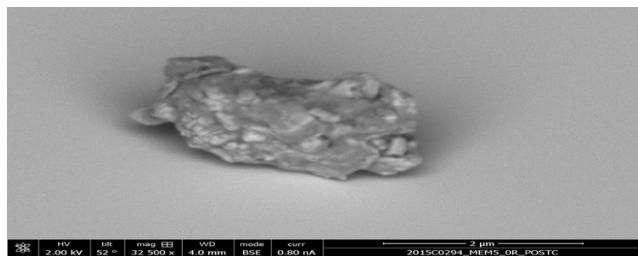
Compromised vacuum during deposition can also lead to defects. As Ti oxidizes, carbon and silicon particles present in the chamber from a compromised vacuum can adhere to the surface. These types of particles can be washed off if they are not trapped in the metal stack. Irregularities in the films from equipment malfunctions are commonly irregular shapes and vary in size.

Figure 2- SEM cross-section of a Si and C particle attached to the top surface of a Ti film due to compromised vacuum.

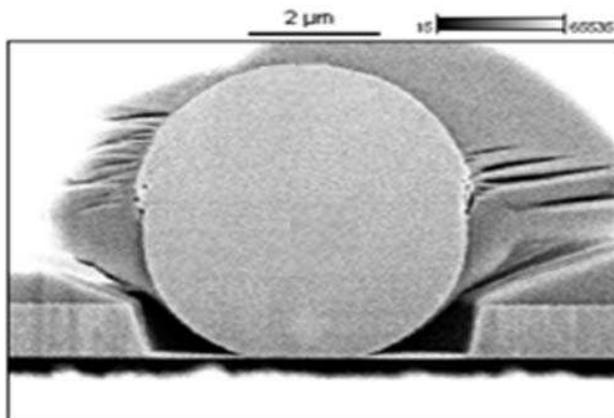
Defects can also form during either the Ti or the Pt deposition steps, as the source material becomes deformed with use. When slug source material is repeatedly used and refilled it eventually loses its truncated conical shape. When this occurs, sufficient electrical contact between the hearth and the slug is lost causing arcing in the pocket. Deformation of the slug can trap air pockets near the evaporating surface which can then erupt when exposed. Again, shifts in the amount of power for a given deposition rate are an indicator of slug source material health, but is not an effective screening method for all excursion event causes.

Defects formed by these types of issues can vary in shape from irregular blobs to spheres (fig 3 and 4).

Figure 3- SEM image of a spherical Pt particle ejected from deformed source material.

Maintaining source materials with a uniform slug shape reduces the likelihood of Ti or Pt material ejection onto the wafers. Maintaining the shape of the slugs is more manageable when starting with preformed starter slugs from the precious metal supplier. Well documented procedures, expertly trained source material handlers, and strict adherence to established guidelines are essential when replenishing the slug source materials.

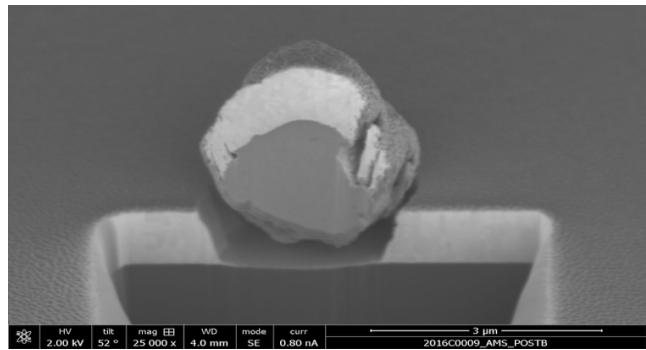
Figure 4- SEM image of an irregularly shaped Pt particle.

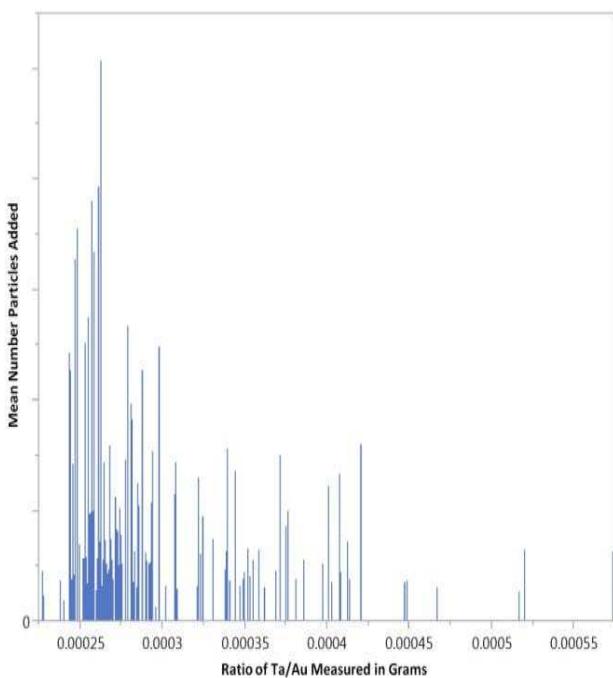
Figure 5- Plot of the Ta to Au ratio measured in grams vrs numbers of particles added during deposition of the bottom plate capacitor metal stack.

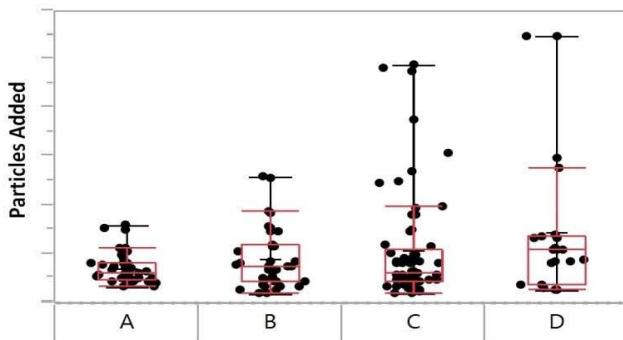
It is our experience that differences in the interpretation and implementation of the source preparation procedures caused differences in particle counts from shift to shift (fig 6).

Figure 6- Plot of particles added by shift that prepared the source material

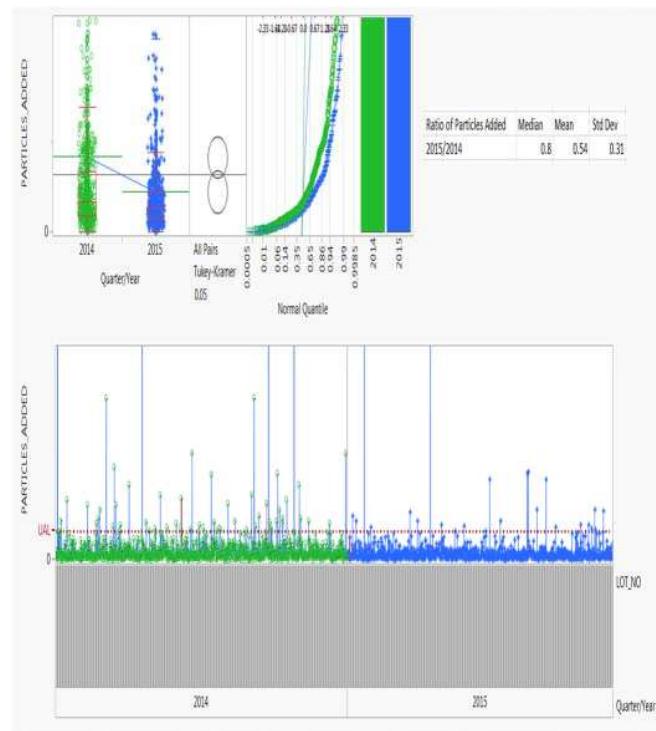
In the graph below data collected from particle monitors processed during the bottom plate capacitor deposition over time is presented. Particle reduction efforts began at the end of 2014. Since then, the methods presented in this abstract have reduced the number of high defect count excursions. The baseline amount of particles added has been reduced by more than half and the run to run variation has been reduced by approximately one third.

Figure 7- Plots of particle added during the bottom plate capacitor deposition sorted by date.
