Analysis of and Solution to Ion Trim Drift Utilizing FDC Software and a Residual Gas Analyzer

Eric McCormick¹, Romek Bobkowski¹, Karsten Mausolf¹, Guy Takayesu¹, Dario Nappa¹, Francis Celii¹, Mike McClure¹, Craig Hall¹, Joseph Raff²

Keywords: BAW Filters, FDC, RGA, PVD

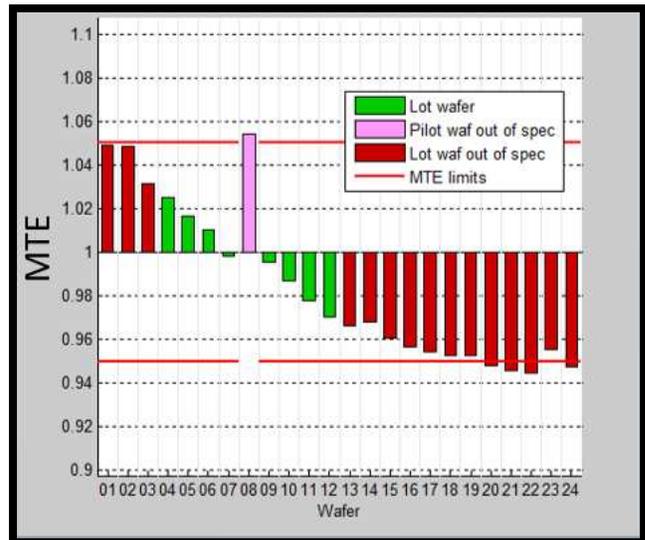
A stubborn exception has been one of the trim processes which frequently shows an across-lot drift in frequency and MTE (Mean Trim Error). The lot in Figure 2 was trimmed based on the pilot wafer, with additional corrections which would have given the pilot wafer an MTE of 1 and frequency error near 0. While the lot trend shows this null-point is correctly positioned at the pilot wafer, we observed an increasingly negative frequency error with increasing wafer number, called Trim Drift. Trim Drift is not specific to device or processing tool.

Figure 2: This lot displays strong Trim Drift, with MTE varying strongly across the lot.

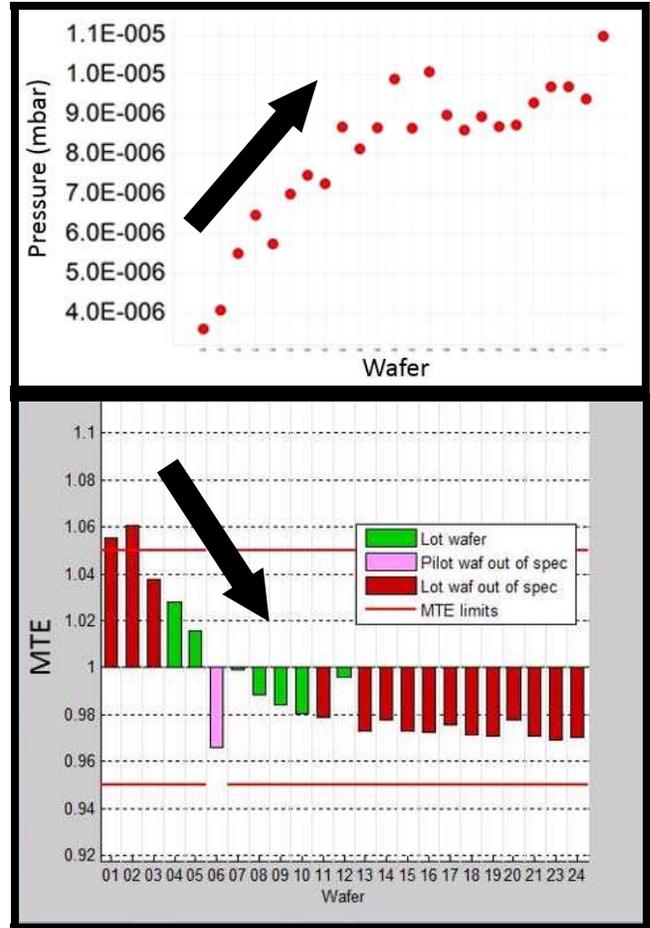
The summary residual gas data in the sputter etch and transfer chambers immediately following this etch step was analyzed. The RGA data was only able to be collected immediately after the process was complete because of the high chamber pressure. The sample summary was typically the average value over 5 seconds. A trend for a particular RGA species was noted which correlated directly with the Trim Drift occurrence. As can be seen in figure 3, when the species trends upwards over the course of a lot, Trim Drift occurs. No other collected species had a consistent correlation trend with Trim Drift.

Figure 3: RGA-data plots for a given species with the associated Trim Report. Each point in the RGA-data plot is collected immediately after a wafer has finished the Sputter Etch step.

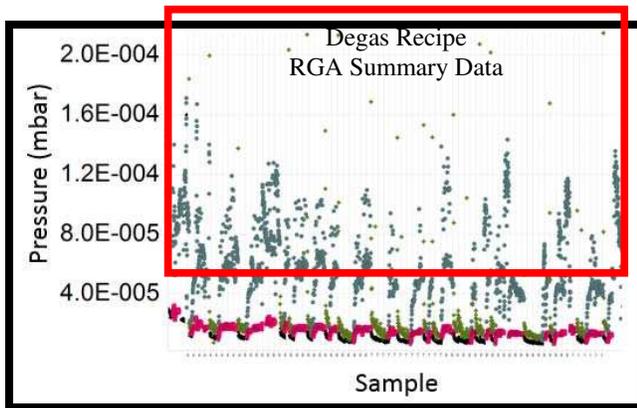
One of the many questions to answer was the reason for the occurrence of Trim Drift. There are multiple recipes running in the sputter etch chamber. One type was a high pressure wafer degas and the other was a sputter etch or a combination of both. The ability to have the context data with each data point like recipe was key to the analysis. Plotting all recipes in a sequence and marking the chart (Figure 4) by recipe shows that the high pressure degas recipes dominate the RGA trend.

Figure 4: RGA-data plots for a given species. Each shade is a different process recipe in the sputter etch chamber.

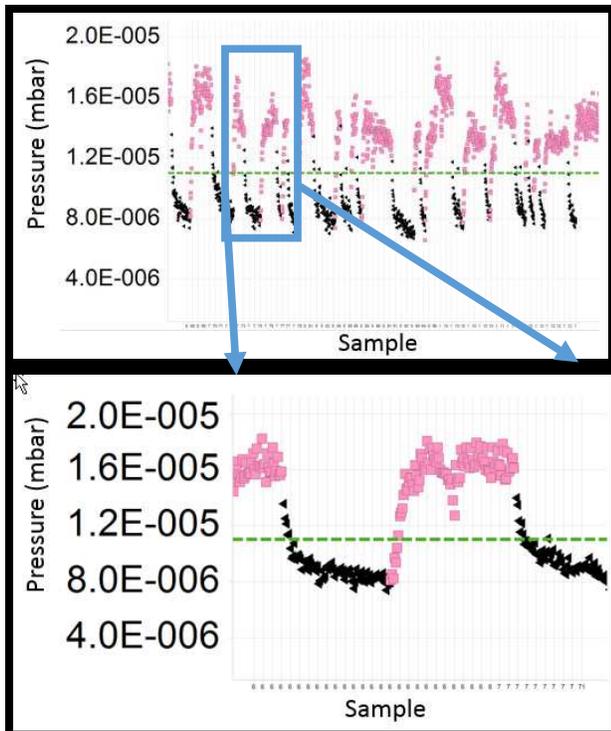
The degas recipe summary data was filtered out of the chart and the increasing trend over time was found to occur only on lots which were processed immediately after a 40 second sputter etch recipe in another operation. The 40 second recipe and the 10 second recipes are identical with the exception of the etch time. The observed increasing trend is due to this phenomenon: **Both the 10 second etch and the 40 second etch have baseline RGA species pressure. As wafers are run, the pressure gradually corrects itself to the baseline.** This can be seen in the Figure 5 below. This phenomenon was observed and verified on all tools that ran this mix of recipes.

Figure 5: Squares are the 10 Second recipe. Triangles are the 40 second recipe.

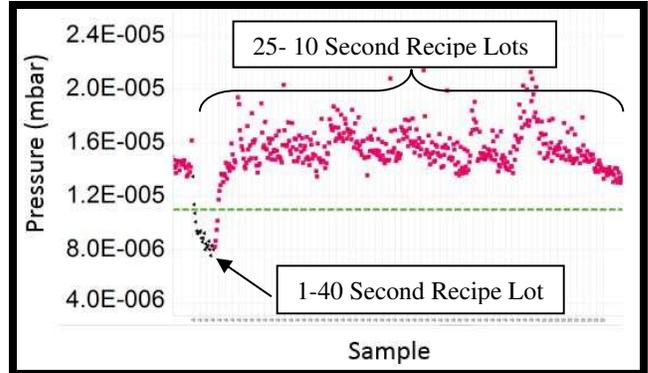
To verify that stability in the RGA signal could be maintained the recipes were isolated. The results are shown in Figure 6 below.

Figure 6: Initial 40 second recipe followed by 25 10 second recipe lots.

The effect was independent of the degas recipe that was run just prior or in between the etch recipes. The effect was also independent of the wafer type being processed (product or blanket dummy). The sputter etch recipes were identical in structure with exception to the time but the solution was now apparent. Either the recipes had to be isolated from each other or conditioning wafers must be run prior to running the recipe that is prone to Trim Drift.
