Reduction in Current Leakage Fails Through an Improved Metal Lift-off Process

J. Hunter, J.K. Abrokwah

Broadcom Limited, Wireless System Division, 4380 Ziegler Rd, Fort Collins, CO 80525
e-mail: Joe.Hunter@broadcom.com, Phone: 970-288-5474

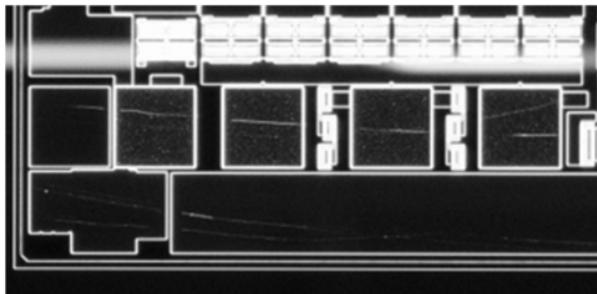
Microscope inspection in dark-field view post MLO revealed the presence of fine scratches across devices as shown in Figure 1. These defects were not observed prior to MLO, such as after mask and after metal deposition. A cross-section of a similar scratch was obtained and is shown in Figure 2.

Figure 1: Fine surface scratches across capacitors post MLO.

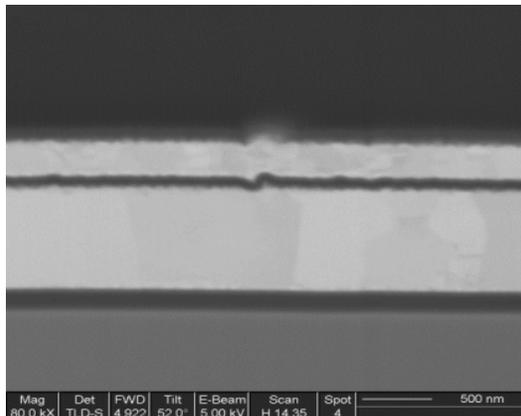
Figure 2: Cross-section of a surface scratch.

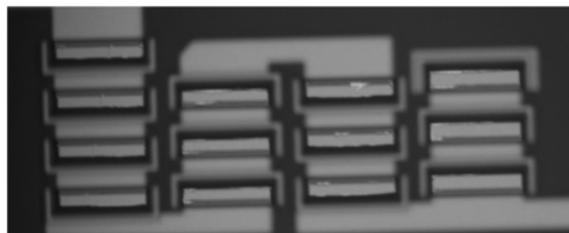
Bright-field optical microscopy revealed on-mesa metal damage post MLO as shown in Figure 3. Such damage also was not observed after mask or after metal deposition. An automated visual inspection (AVI) technique detects these defects, which are described as Pattern Bright defects.

Figure 3: On-mesa metal damage caused by MLO process, described as Pattern Bright defects.

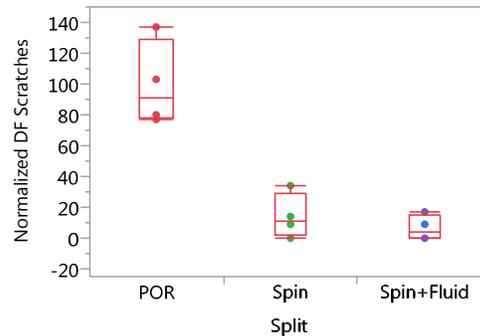
It was found that the wafer spin speed and the amount of solvent on the wafer during the MLO spray process affected the number of scratches and Pattern Bright defects [1]. Figures 4-9 show the reduction in scratches observed with preferred MLO recipes for lots 1-6. Normalized DF scratches were determined by dividing the number of dice scratched by the mean of scratches for all POR wafers. In the figures

Figure 4: Lot 1, circuit A. Effect of MLO process variable on dark-field visible scratches.

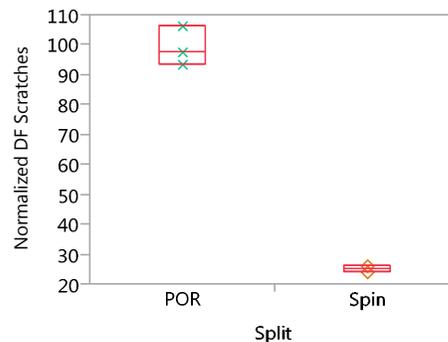
Figure 5: Lot 2, circuit A. Effect of MLO process variable on dark-field visible scratches.

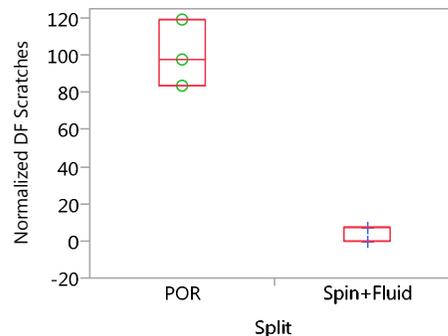
Figure 6: Lot 3, circuit B. Effect of MLO process variable on dark-field visible scratches.

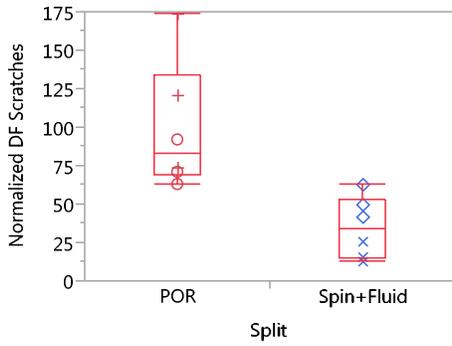
Figure 7: Lot 4, circuit C. Effect of MLO process variable on dark-field visible scratches.

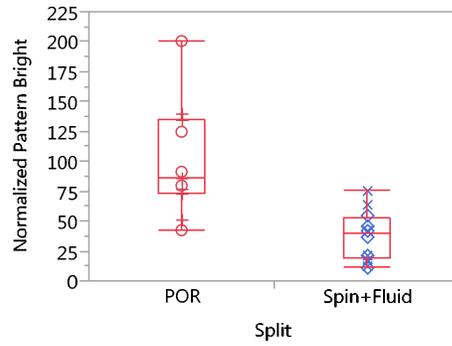
Figure 10: Lot 4, circuit C. Effect of MLO process variable on AVI Pattern Bright defects.

Figures 10-12 demonstrate the effect of MLO processing on Pattern Bright defects using an AVI recipe that enhanced such defects. Normalized Pattern Bright defects were determined by dividing the number of defects for each wafer by the mean of the Pattern Bright defects for all POR wafers.

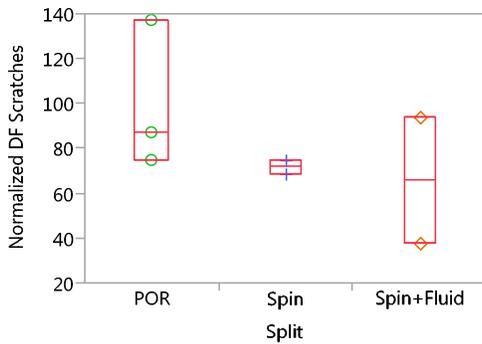
Figure 8: Lot 5, circuit D. Effect of MLO process variable on dark-field visible scratches.

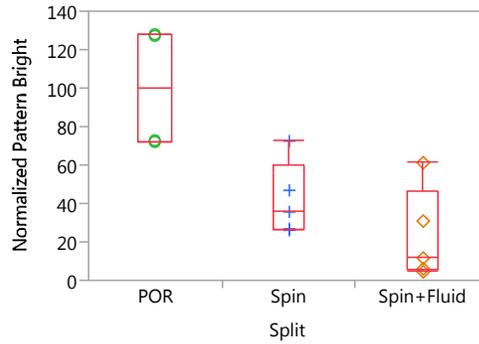
Figure 11: Lot 5, circuit D. Effect of MLO process variable on AVI Pattern Bright defects.

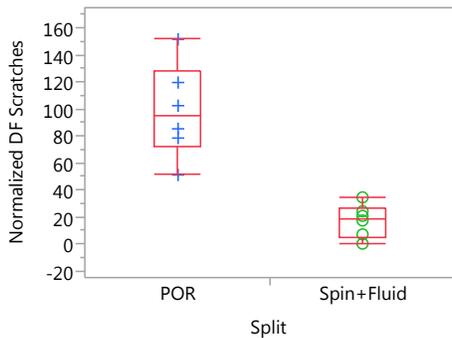
Figure 9: Lot 6, circuit D. Effect of MLO process variable on dark-field visible scratches.

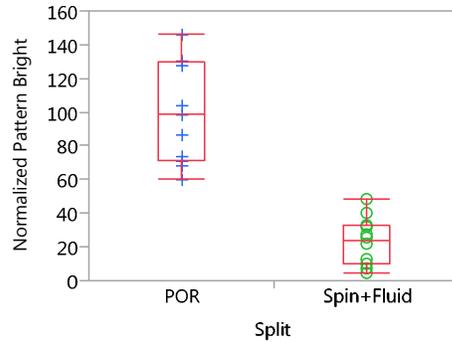
Figure 12: Lot 6, circuit D. Effect of MLO process variable on AVI Pattern Bright defects.

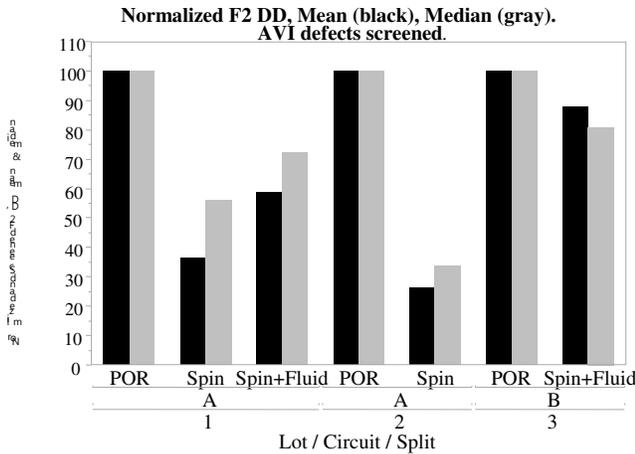
Figure 13 shows the current leakage results in terms of normalized defect density for lots 1-3. The defect density (DD) was obtained by counting the number of fails at the medium stress test and dividing by the total capacitor test area. The DD for the split lots was then obtained by normalizing to the mean and median of the POR defect density. "F2" refers to the medium voltage stress test. A fail at F2 corresponded to leakage current greater than 100 nA. Dice containing any AVI defect were removed from the analysis in order to better correlate current leakage fails to fine scratches caused by MLO, yet not visible to the AVI.

Figure 13: Current leakage fails as a function of MLO process.

There is a direct relationship between fine scratches, on-mesa metal feature damage and current leakage. However, the circuit layout is an important consideration. For example, the reduction in current leakage fails for lot 3 was less than that of lots 1 and 2 because there was much less capacitor area for circuit B compared to circuit A. This may have been predicted by the count of fine scratches if only the scratches across capacitors, not other devices on the dice were tabulated.
