# Wafer Breakage Reduction in Cu Bump Processing of GaAs Technologies

Qorvo, 2300 N.E. Brookwood Parkway, Hillsboro, Oregon 97124

Efforts to reduce wafer breakage events during Cu bump manufacturing of GaAs technologies were discussed in this paper. Wafer backside residue and scratches formed during upstream processes were found to cause stress breaks at the Cu plating step. A correlation of wafer edge chipping at the lamination process and downstream finish processes was discovered. The fishbone diagram was used to investigate frequent wafer stress breaks at Cu field metal etch process. As a result, the overall wafer breakage rate was reduced by more than 50% in Cu bump processing.

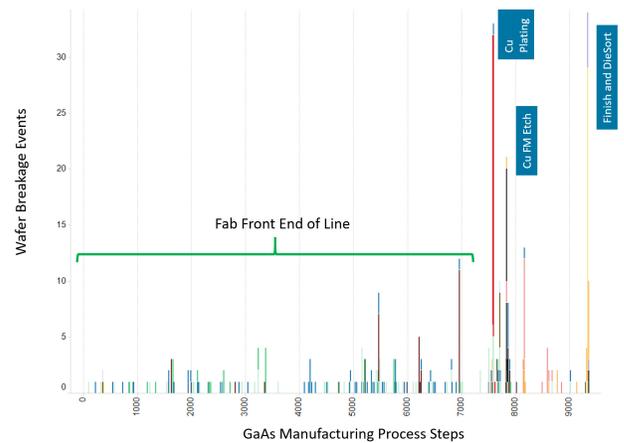
To understand the causes of high wafer breakage rate, the broken wafer scrap data was analyzed by process steps. Figure 1 shows the GaAs wafer breakage events at different manufacturing process steps. The data indicated baseline level wafer

breakage across front-end-of-line processes, but wafer breakage occurred more often during Cu bump and fab finish process steps. Since wafers are more valuable at the backend of the process, this study is focused on reducing wafer breakage rate during Cu bump processing.

Figure 1. Wafer breakage scraps at different process steps during GaAs manufacturing

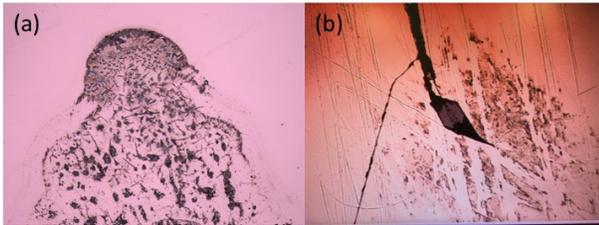
**Figure 2. (a) Residues present on the backside of the wafer incoming to Cu bump plating step (b) Microcrack observed after removing the residue**

Further investigation of the broken wafers indicated residues on the backside of the wafers makes the wafers more susceptible to breakage during Cu bump plating handling. The residue was normally found at the center of the wafer and could cause vacuum issues. The wafers may drop during handling or become misaligned inside of the tool. For the wafers that cannot be picked up by the tool and are still intact, manual scraping is required to remove the residue. However, microcracks will be introduced during manual residue removal and will lead to stress breaks later as shown in Figure 2(b).

A combination of efforts to reduce wafer backside residue at upstream process steps and the subsequent

residue removal process on the incoming wafers have reduced the wafer breakage rate at Cu bump plating step by > 70%.

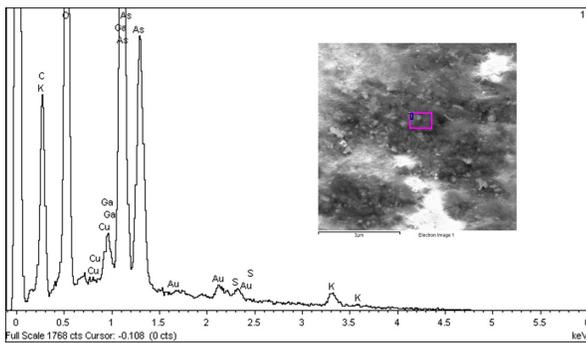
**Figure 3. EDS analysis of wafer backside residue incoming to Cu bump plating process**

EDS analysis of the wafer backside residue revealed the presence of K and Au elements. This indicated the residue was formed during an upstream sink process. Inline inspection was performed and confirmed the root cause of residue formation.

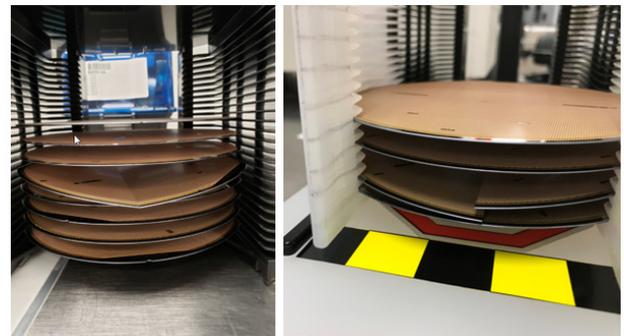
The second highest wafer breakage step during Cu bump fabrication is the field metal etch process. The broken wafers were found to have a specific stress break pattern. When the stress break was found, the broken wafers were always sitting in the cassette broken into two pieces with the breakage plane facing the top of the cassette. The wafers were not typically aligned at the field metal etch process, but the broken wafers were always the ones with 8 o'clock or 2 o'clock at the top of the cassette, as shown in Figure 4.

**Figure 4. Pictures of broken wafers found at field metal etch process. Signature of 8 to 2 o'clock stress break with breaking plane always facing the top of the cassette.**

This unique breakage pattern indicated two potential failure modes. One hypothesis is that there was excessive force applied to the wafer edge that caused stress break when the force was applied to 8 or 2 o'clock. This failure mode pointed to the slide transfer used at Cu field metal etch process. Multiple wafer transfers between PEEK and teflon cassettes are required during preclean and field metal etch processes. The wafer transfers are performed using a manual slide transfer. It was found that the handle of the slide transfer arm drifted down. If the handle was not lifted properly, there will be an angle between the pusher and wafers therefore causing extra force

on the wafers. If the slide transfer was touching at the crystal plane of the GaAs wafers, the wafers were likely to break along the plane.

After replacing the slide transfer for Cu bump processing and refreshing slide transfer training, the wafer breakage rate was reduced at Cu field metal etch process. However, frequent breakage events still remained.

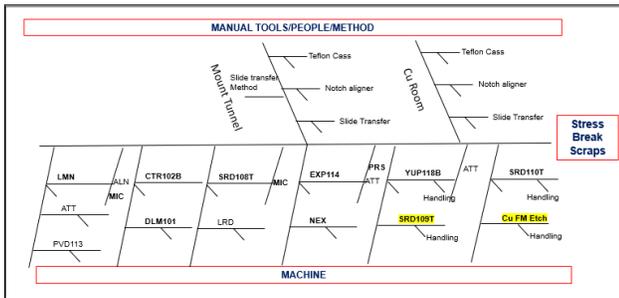
The other failure mode that could explain the 8 or 2 o'clock breakage was damage from a previous step that only broke after the slide transfer motion. The backend engineering team did a Fishbone analysis to identify possible steps/processes that could cause micro damage on the wafer, as shown in Figure 5.

Figure 5. Fishbone diagram to troubleshoot root cause of stress break at field metal etch process.

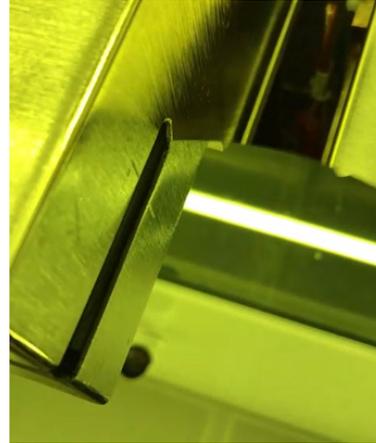
During an extensive equipment handling check, it was found that a tool cover was slightly touching the wafer edge when the robot was moving the wafer into the tool as shown in Figure 6. The wafer did not break at this step and no obvious damage was observed, but if the wafer was rotated so that the 8 or 2 o'clock crystal plane touched the tool cover, the wafers were more likely to break during a later slide transfer process step. The tool cover was then modified to have more clearance during the wafer handling. With these combined improvements, the wafer breakage rate was significantly reduced at the field metal etch process.

Figure 6. A tool cover was found touching the wafer edge when the wafer is moving into the tool.

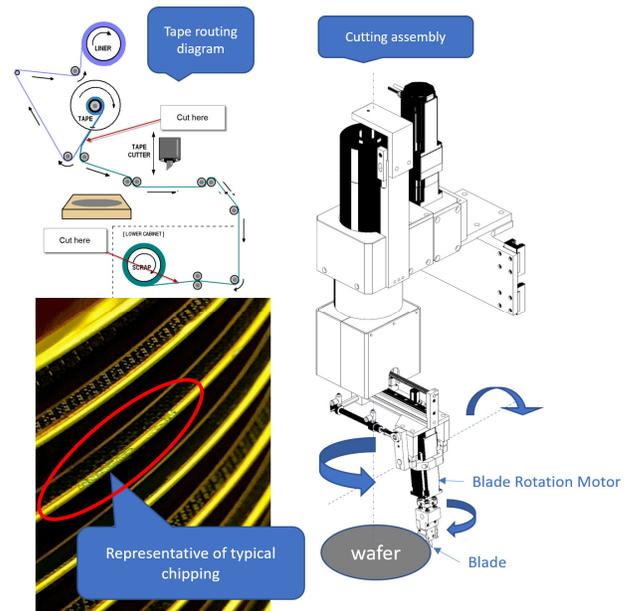
Figure 7. Wafer edge chipping formed during lamination cutting step. Equipment schematics is from Microcontrol Electronic.

During an investigation of multiple lots having wafer breaks, it was found that the broken wafers were from the same parent lot in the upstream process. A closer look at the broken wafers revealed commonality of wafer edge defects that contribute to the origination of the wafer breakage. The wafer edge was covered with metals, so the defects were hard to detect. Inline inspection was implemented at upstream processes to identify the source of wafer edge defects.

Upstream inline inspection showed that intermittent wafer edge chipping was observed after the lamination process, from particular lamination equipment. Minor edge chipping/scraping was found after the cutting step. The cutting blade also showed abnormal wear prior to a scheduled PM, validating the failure mode.

Tool matching work including cutting angle adjustment and PID setting optimization to reduce vibration of the cutting process was performed reducing wafer edge chipping at this step and wafer breakage in the sort and finish areas.

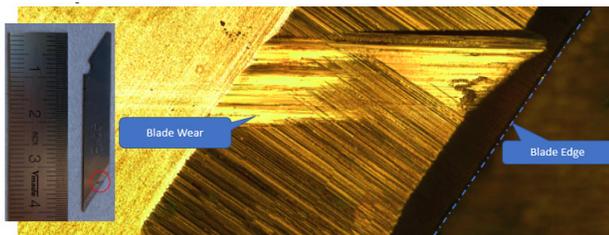
**Figure 8. Wearing of the cutting blade indicated vibration causing wafer edge chipping.**

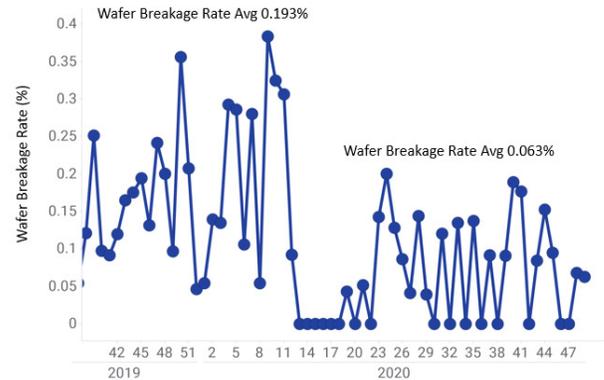
In this paper, we discussed three wafer breakage reduction improvement projects in Cu bump process. With the implemented preventative actions, the wafer breakage rate of Cu bump fabrication has been reduced by more than 50%, and a new baseline with a lower wafer breakage rate was achieved, as shown in Figure 9.

**Figure 9. Wafer breakage rate of Cu bump process by work week. New low wafer breakage baseline was achieved after the improvement project.**
