Role of Electrochemical Reactions in the Degradation Mechanisms of AlGaIn/GaN HEMTs

Feng Gao^{1,2}, Carl V Thompson², Jesús del Alamo, and Tomás Palacios

Abstract

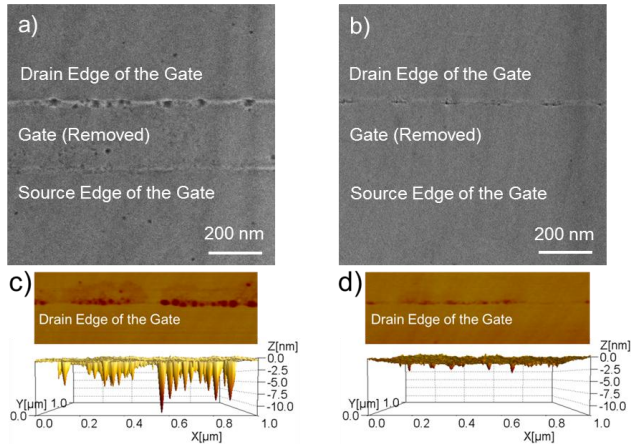
After the removal of the gate metal, the exposed surface in the gate area of these electrically-stressed HEMTs was investigated using scanning electron microscopy (SEM) and atomic force microscopy (AFM). Fig. 1 shows the top view and depth profile of the surface area around the gate of the HEMTs that were stressed in ambient air and in vacuum. It can be seen that the mean size and density of the surface pits were significantly higher in the HEMTs stressed in ambient air than those stressed in vacuum.

Fig. 1. SEM and AFM analysis of the AlGaIn/GaN HEMTs stressed at $V_{gs} = -7$ V and $V_{ds} = 43$ V for 3000 s after gate metals were removed: SEM top view (a) and AFM depth profile (c) in ambient air; SEM top view (b) and AFM depth profile (d) in vacuum of 1×10^{-7} Torr.

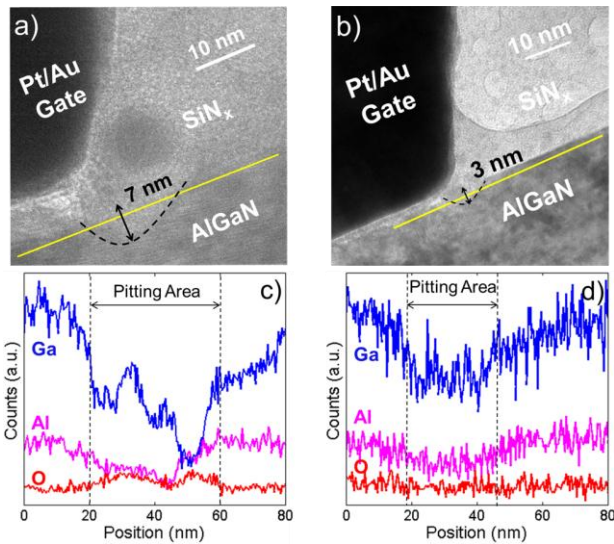
passivation and gate metals. A smaller pit size was again found in the devices stressed in vacuum when compared with those stressed in ambient air as shown in Fig. 2 (a) and (b), respectively. In addition, the material in the surface pits was characterized using energy dispersive X-ray analysis (EDX). A low concentration of gallium and aluminum and a high concentration of oxygen were observed inside the pit, as shown in Fig. 2 (c) and (d), indicating the important role of oxygen in the structural degradation of AlGaIn/GaN HEMTs.

Fig. 2. Cross-sectional TEM images at the drain edge of the gate in the AlGaIn/GaN HEMTs stressed at $V_{gs} = -7$ V and $V_{ds} = 43$ V for 3000 s in ambient air (a) and in a vacuum of 1×10^{-7} Torr (b); EDX line analysis across the pitting area for the above HEMTs stressed in ambient air (c) and in vacuum (d). The EDX line scan is indicated as the yellow line in (a) and (b).

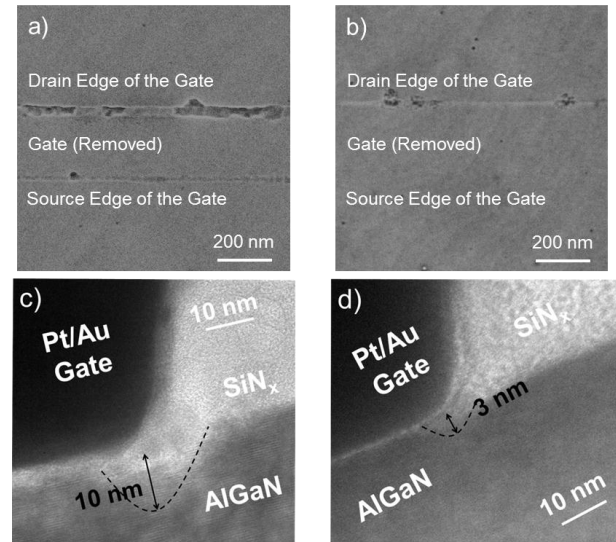
Given that surface pitting is reduced when the devices are electrically stressed in vacuum conditions, the oxygen in the pits is most likely from the oxygen gas O_2 and/or moisture H_2O present in ambient air. In order to discriminate between these two options, another two chips of five identical AlGaIn/GaN HEMTs were stressed in the chamber at the same OFF-state bias and duration in water-saturated Ar and in dry Ar. As shown in Fig 3, the surface pitting was significantly accelerated by water-saturated Ar with respect to dry Ar, which directly supports the water molecules as the cause of the surface pitting.

Fig. 3. SEM images of AlGaIn/GaN HEMTs stressed at $V_{gs} = -7$ V and $V_{ds} = 43$ V for 3000 s in water-saturated Ar (a) and in dry Ar (b), after gate metals and passivations were removed; Cross-sectional TEM images at the drain edge of the gate in AlGaIn/GaN HEMTs stressed in water-saturated Ar (c) and in dry Ar (d) before etching.

The difference in the pit sizes between water-saturated and dry Ar was also reproducible in other gas environments including air, oxygen gas (O_2), nitrogen gas (N_2) and carbon dioxide gas (CO_2). The very small surface pitting observed in dry O_2 and dry CO_2 further confirms that the oxygen found in the surface pits comes mainly from water.

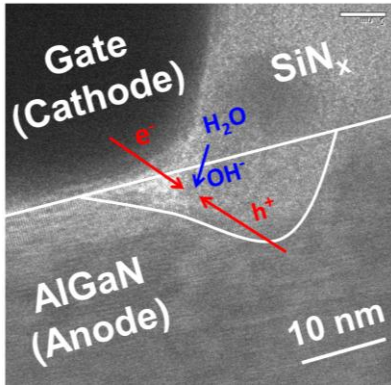
We therefore propose that a water-assisted electrochemical reaction or corrosion process is a significant contributor of the surface pitting observed after OFF-state degradation in AlGaIn/GaN HEMTs. The gate- SiN_y - $Al_xGa_{1-x}N$ region at the gate edge forms an electrochemical cell which causes anodic oxidation of the $Al_xGa_{1-x}N$ layer (Fig. 4). The reaction starts at the GaN cap surface and then proceeds into the AlGaIn barrier during the electrical stress. For simplicity, we use $Al_xGa_{1-x}N$ to indicate both the GaN

In the electrochemical cell, the gate metal acts as the cathode, which provides electrons to the water at the interface between SiN $_y$ and Al $_x$ Ga $_{1-x}$ N when the gate-to-drain diode is reversed biased. The corresponding reduction reaction for the water is:

The electrons contribute to the total gate current. On the other hand, the Al $_x$ Ga $_{1-x}$ N layer acts as the anode and is decomposed and subsequently anodically oxidized in the presence of holes and hydroxyl ions (OH $^-$) following:

Fig. 4. An electrochemical cell formed at the drain edge of the gate in AlGa $_x$ N/GaN HEMTs under high OFF-state drain bias.

The decomposition of the Al $_x$ Ga $_{1-x}$ N (the GaN cap and the AlGa $_x$ N barrier) causes the surface pitting that was observed in the SEM, AFM and TEM analyses. The subsequent formation of the aluminum and gallium oxides explains the origin of the high concentration of oxygen in the pitting area.

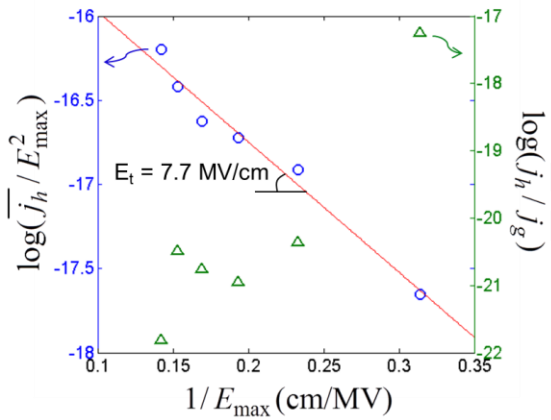
$\log(\overline{j}_h/E_{\max}^2)$ as a function of $1/E_{\max}$ using the simulated values of E_{\max} is shown in Fig. 5. It can be seen that $\log(\overline{j}_h/E_{\max}^2)$ follows a linear trend with $1/E_{\max}$ in agreement with equation (6), supporting the hypothesis that hole-generation is caused by inter-band tunneling. At the same time, $\log(\overline{j}_h/\overline{j}_g)$ as a function of $1/E_{\max}$ is also plotted in Fig. 5. As can be seen, the hole current needed to feed the growth of the pits is just a very small component of the total gate current. More importantly, $\log(\overline{j}_h/\overline{j}_g)$ is an increasing function of $1/E_{\max}$, which opposes equation (5) and indicates that the holes that contribute to pitting are not the result of impact ionization.

Fig. 5. $\log(\overline{j}_h/E_{\max}^2)$ (blue circles) and $\log(\overline{j}_h/\overline{j}_g)$ (green triangles) as a function of $1/E_{\max}$. The number of holes extracted from the volume of the pits seems to follow the inter-band tunneling model – left y axis and not the impact ionization model – right y axis.
