# OPTIMIZATION OF ELECTROPLATING PROCESSES FOR COPPER BUMPS

Elizabeth Tan Calora and Travis Abshere

TriQuint Semiconductor, 2300 NE Brookwood Parkway, Hillsboro, OR 97124  
ecalora@tqs.com, (503) 615-9882  
tabshere@tqs.com, (503) 615-9445

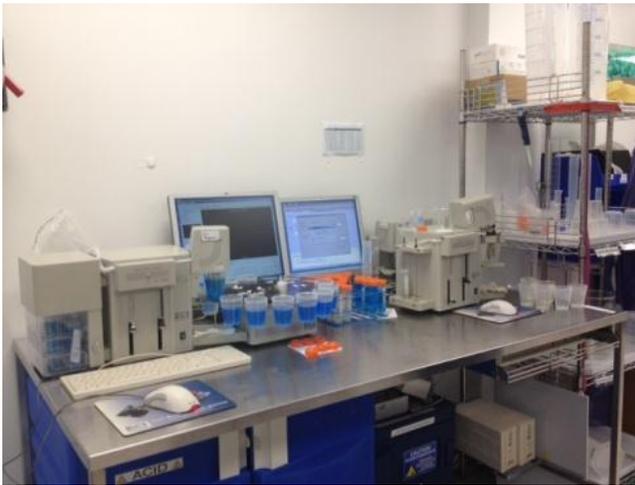
**Figure 3:** Chemical Monitoring System

The chemical monitoring system (Figure 3) involves chemical analysis of the plating bath solution on a regular basis. Cyclic voltammetric stripping technique is used in measuring the effective concentration of most of the organic components in the plating bath solution. Potentiometric titration, on the other hand, is used in determining concentrations of inorganic components in the plating bath solution. As more data was collected, the control limits for their concentrations were established. Once the concentrations in the plating bath solution reached certain limits, a plating bath adjustment would be made. A tool qualification then followed after bath adjustment before turning the tool back to production.

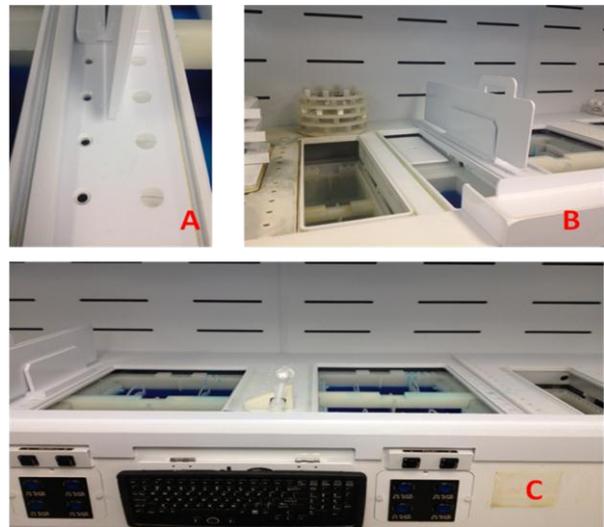
**Figure 5:** Modifications to Plating Bench

The plating bath sinks were modified to help control the plating chemistries (Figure 5). First, holes on the deck (Figure 5A) that were placed to allow liquid drain during deck cleaning were found to be dripping water into the edge of plating tanks. These holes were plugged to prevent

dilution or contamination of plating tanks. Second, a tank cover (Figure 5B) was fabricated to serve 2 purposes: (1) to prevent water getting into the tanks while spraying wafers; and (2) to cover the Pre-Clean Tank when not in use. The amount of water getting into the electroplating tank nearest to the location where wafers are wet was significant. Putting the cover across the Pre-Clean and the electroplating tank led to tighter control of concentrations of components in the electroplating solution. Without the cover, the electroplating solution had to undergo bath adjustment almost every 2 weeks. With the cover blocking any splashing of water, the bath adjustment was reduced to once every month. Finally, the sink was modified by adding a trough in front of the sink (Figure 5C). This allowed the operators to move wafers across this trough instead of across tanks. Thus, by implementing all of these 3 hardware changes, critical causes for either diluting the electroplating tank with water or contaminating the tank with chemicals were eliminated. Bath adjustment is now carried out only every 2 months. Finally, preventive Maintenance procedures were revised to reduce intrusion to the plating bath solutions allowing further control of chemistry consistency. Sufficient conditioning of anodes is carried out when a given PM activity involves some form of intrusion on anodes.
