Improved Availability for Copper Plating Tools

Patrick Santos and Jens Riege

Skyworks Solutions, Inc., 2427 Hillcrest Drive, Newbury Park, CA 91320,
Patrick.Santos@Skyworksinc.com, Jens.Riege@Skyworksinc.com

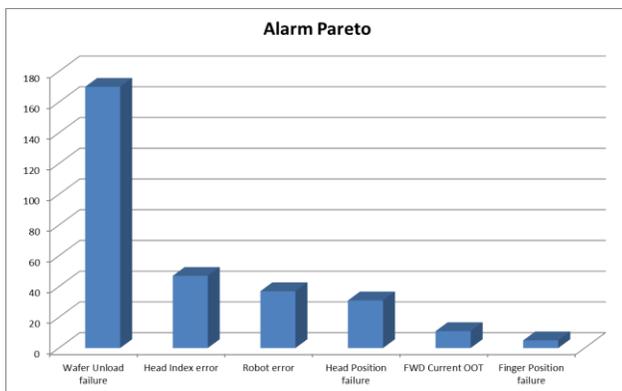
Figure 1. Alarm Pareto for copper platers

To drive equipment improvement, we analyze the top equipment issues and track them weekly. We then attack the top items to drive increased availability. Failure modes related to wafer oxidation consistently have been our top failure Pareto for the copper platers (Figure 1).

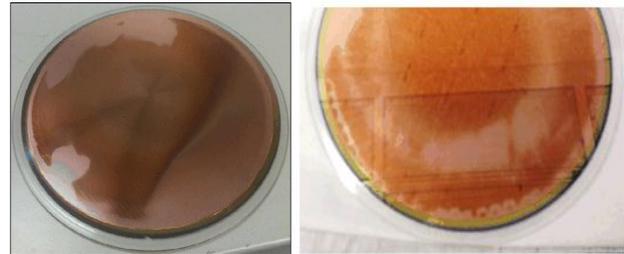
Figure 2. Wafer oxidation over time

Copper oxidation occurs within minutes when a plated wafer is exposed to oxygen in the air and even faster if the wafer is still wet or damp with copper bath solution or DI water. There are different degrees of wafer oxidation depending on the amount of time the wafer is idle. Equipment failures can cause the wafers to be exposed to air longer than the standard process time, and to be exposed when the wafers are still wet. This extra exposure leads to oxidation. Figure 2 shows some examples.

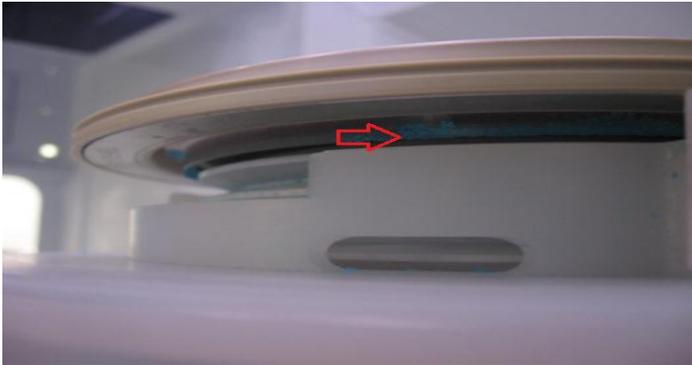
Figure 3. Cu crystals build up

By drilling down we found that our most common equipment failure mode was “Wafer Unload Failures”. These errors result from Cu contamination on the robot end effectors.

The Cu solution now in crystal form (Figure 3) would build up under the wafer ring seal and eventually find its way on to the end effector as it goes to retrieve the wafer. This will cause improper vacuum and inhibit the tool’s automation, leaving the tool in an idle state until the problem can be acknowledged. Even though equipment support responds quickly to these events, the wafer is already oxidized before they can get to the tool.

To eliminate the spread of the Cu solution, more stringent PMs were put in place. We now require daily cleaning of the ring seals. In addition, a ceramic end effector is now used to withstand the exposure to the Cu solution (Figure 5).

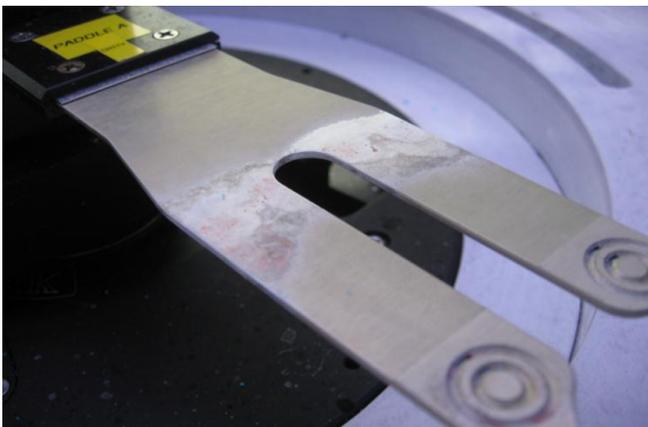
Figure 4. Cu solution attacking the aluminum end effector

Another casualty from the Cu contamination is the damage to the robot end-effectors (Figure 4). Over time we have seen the robot end effectors deteriorate from Cu exposure to the point where their seals become damaged.

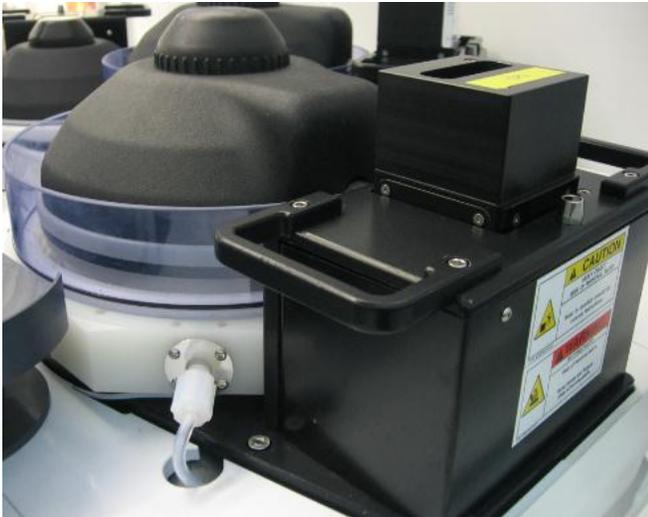
Figure 6. Head position CLOSED

Next we addressed the root cause for the crystal build up. We found this was due to improper positioning of the Z-axis when the head is in the closed position. We found in some cases that the closed position is set too deep in the Cu solution. This causes the Cu solution to get on back of the ring seals. As the heads open, this causes a “scooping” effect.

Because of the design of our tool we do not have the ability to see the depth of the wafer in the solution with the head closed (Figure 6). Instead, we had been relying on a trial and error method to ensure the wafer comes in contact with the bath meniscus for optimal plating. In most cases we either over compensated or caused damage to the tool.

To eliminate the guesswork, a Pyrex fixture (Figure 7) was made to help us find a depth height reference point.

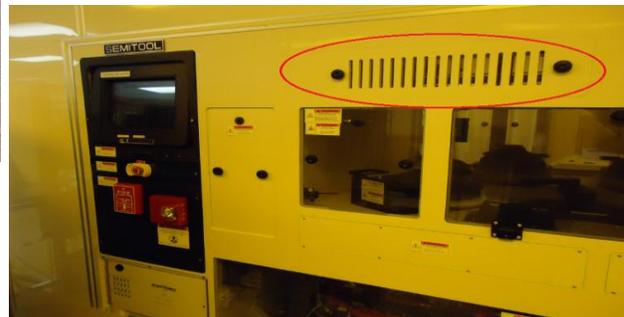
Figure 9. Plating cabinet louvers to block air flow (circled).

The plating cabinet design provides significant laminar flow across the upper cabinet deck because this cabinet is designed for a variety of end uses and for materials such as strong acids, bases, and solvents. High laminar flow is not required and is detrimental for a copper plating bath. The upper cabinet was designed with louvers that can be closed to block air flow. Unfortunately, plastic does not easily hold its shape, and significant air flow still made its way through the gaps. When we fully blocked the air flow, oxidation was significantly reduced (Figure 9).

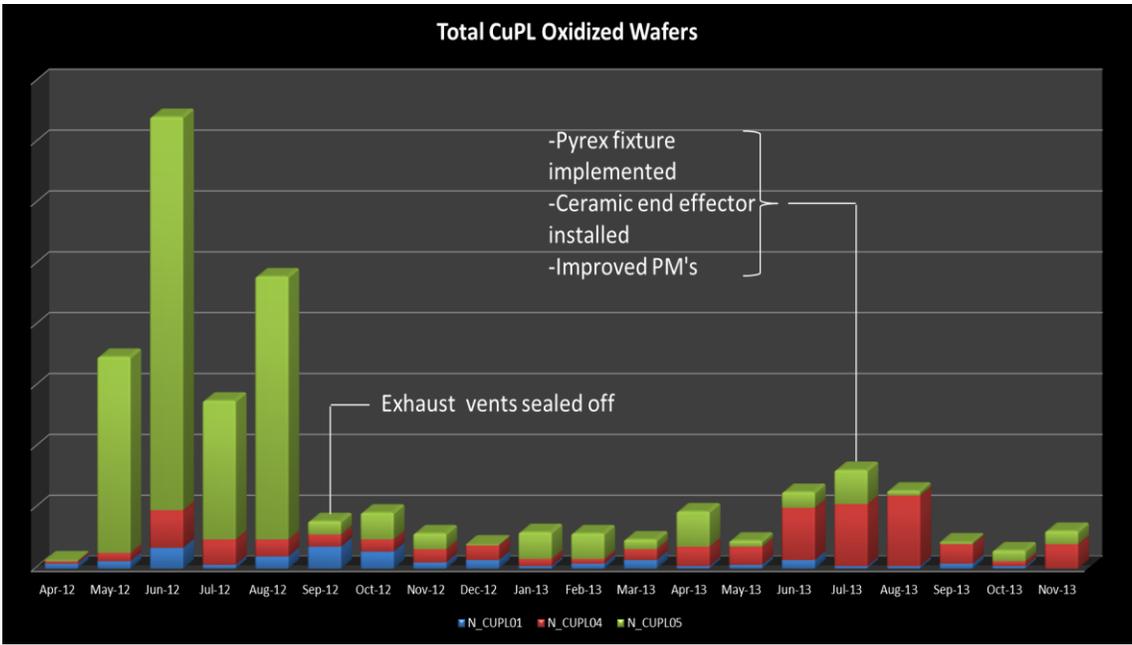
Figure 10. Trend chart

The combination of all three changes has improved our wafer handling and minimized the number of wafers impacted by wafer oxidation related events as shown in (Figure 10.)
