Final Module Yield Improvement by Increasing the Adhesion of SU8 to Microelectronic Devices using a DMAIC approach

TriQuint Semiconductor, 500 W Renner Road, Richardson, TX 75080

Keywords: WLP, SU8, DMAIC, Yield

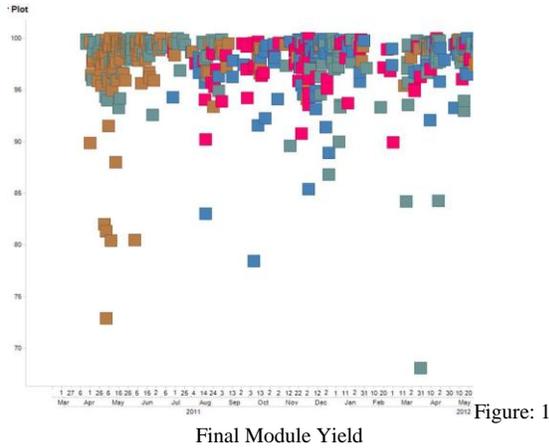
Figure: 1

These indicators were analyzed using several tools: Pareto charts, trend charts (Figure 1), Final Module Yield, Figure 2: (Shear Data of SU8), box plots, and histograms that helped in understanding the problems and to prioritize the issues.

Final Module Yield

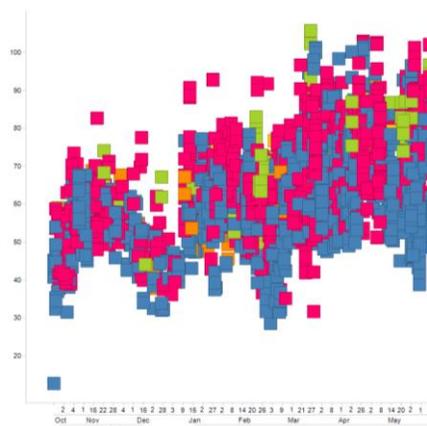
Figure 2: Shear Data of SU8

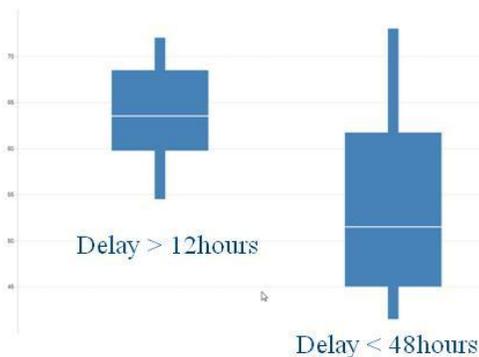
This data was analyzed using 6 sigma and Spot-Fire tools such as correlations and histograms and box plots to verify or discard the causes. In Figure 4: Delay between Develop and Cure, a 48 hour delay resulted in a 17% decrease in shear strength.

Figure 4: Delay between Develop and Cure

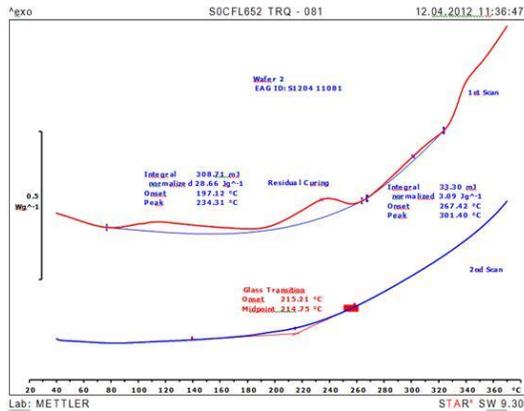
Investigation into the cross linking of the SU8 using the standard cure oven indicated that the SU8 was not fully cross linking, regardless of the temperature and time the SU8 was exposed to. Cross linking is a key indicator of the film SU-8 stability. Cross linking begins at the exposure step where there is formation of a strong acid during the exposure process and is followed by acid-initiated, thermally

To determine the complete curing of SU8 TGA (Thermal Gravimetric Analysis) was used to test the thermal stability. A controlled hard bake (cure) temperature slightly below glass transition phase temperature will fully cross link the material. As can be seen in Figure 5: TGA Data for Process of Record, the SU8 is not fully cured as indicated by residual curing still taking place.

Figure 5: TGA Data for Process of Record

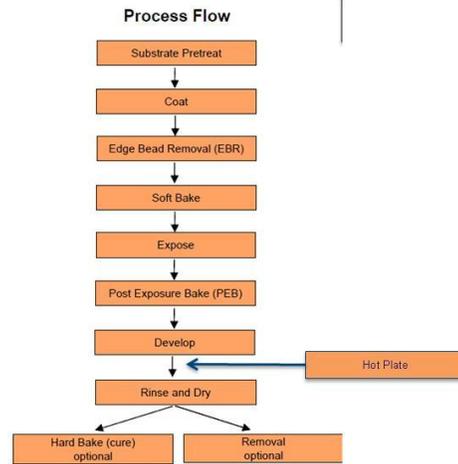
Figure 6: Process Flow

A design of experiments was used varying methods of curing, and curing times and temperatures as well as placement in process flow. Inserting a hot plate cure after the develop step, as shown in Figure 6: Process Flow, resulted in fully cross linking the SU8 as verified in Figure 7: TGA Data for New Process of Record

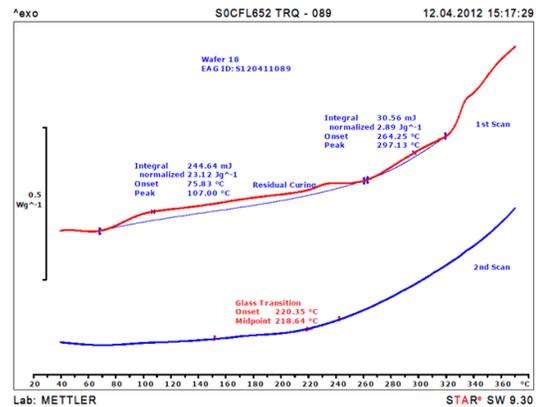
Figure 7: TGA Data for New Process of Record

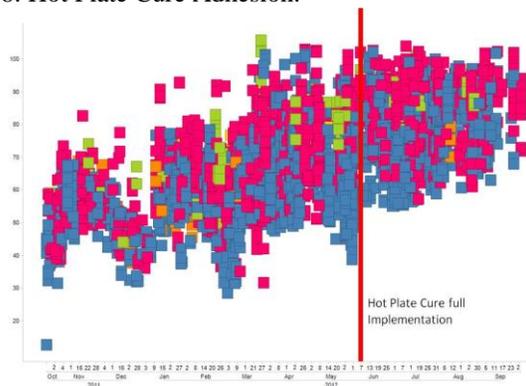
Testing and implementation of a hot plate cure immediately after develop resulted in the shear (adhesion) values not only increasing but the variation decreased as well. This is shown in Figure 8: Hot Plate Cure Adhesion.

Figure 8: Hot Plate Cure

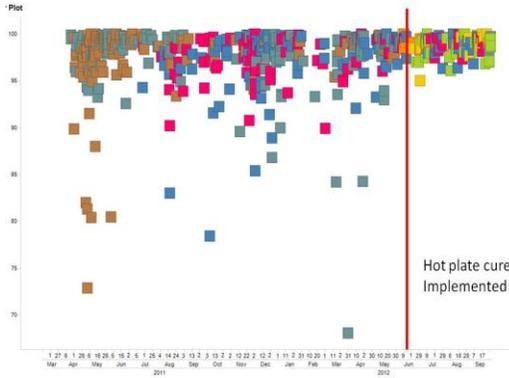
The most important aspect of this project was final module yield. As shown in Figure 9: Final Module Yield and Hot Plate Cure, the module yield has been stabilized.

Figure 9: Final Module Yield and Hot Plate Cure
