Electrochemical Etching of Ion Implanted Channel Regions in GaAs

J. Crites, J. Dilley, S. Kittinger, W. Pickens, W. Polhamus, M. Balzan, M. Drinkwine
 Cobham Blacksburg, 3155 State St., Blacksburg, VA 24060
 Phone: 540 443-2800, E-mail: james.crites@cobhamdes.com

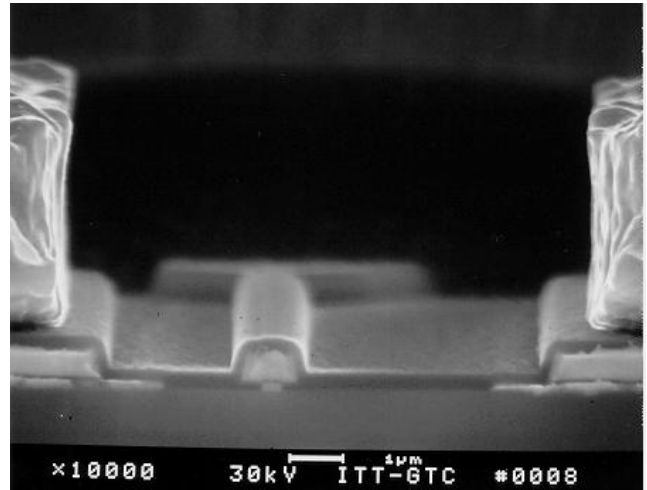
planar-processing approach, the GaAs topology is featureless extending from the source to the drain as shown in the SEM FET cross section in Figure 2.

Figure 2. SEM cross section picture of MSAG FET showing the planar structure without a recessed gate.
